Wooden Artifacts in Cemeteries

A Reference Manual

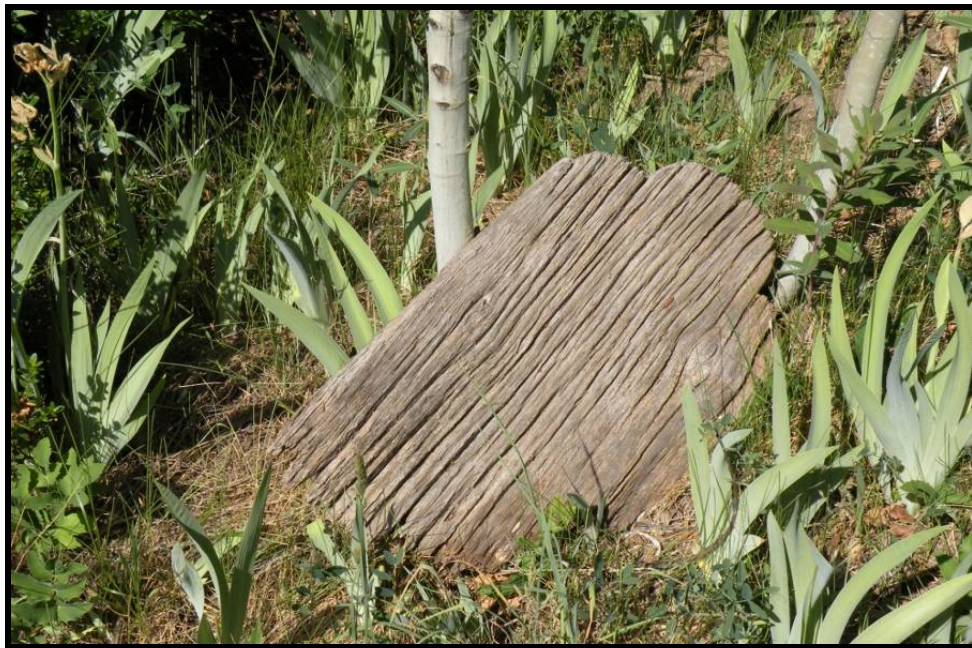
Figure 1. A grave marker with the gray wood typical from UV exposure and weathering-caused cracks and checks that allow moisture penetration

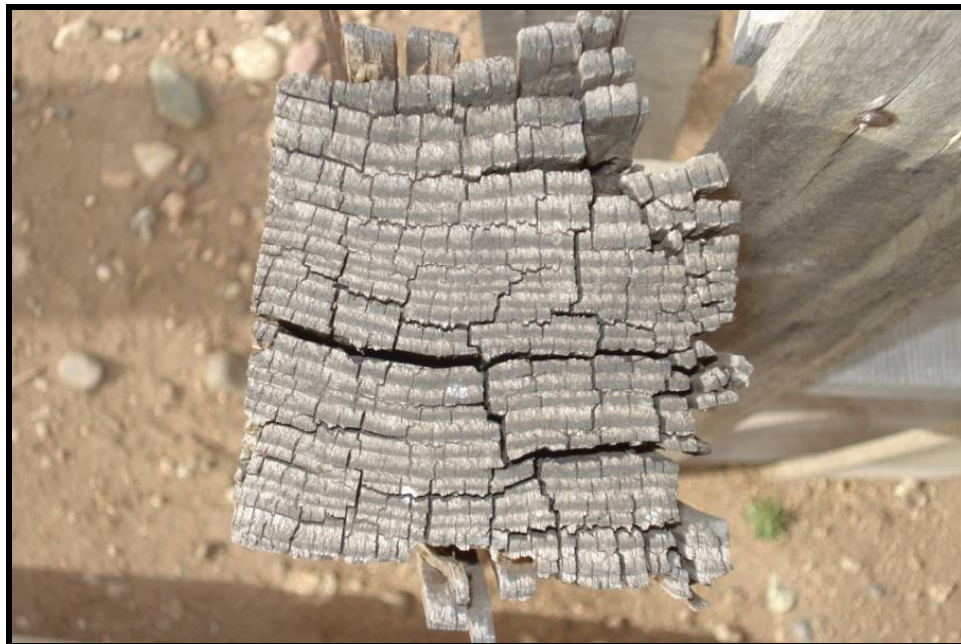
Figure 2. The top of a grave enclosure corner post showing splits developing from cyclic moisture or freeze/thaw episodes.

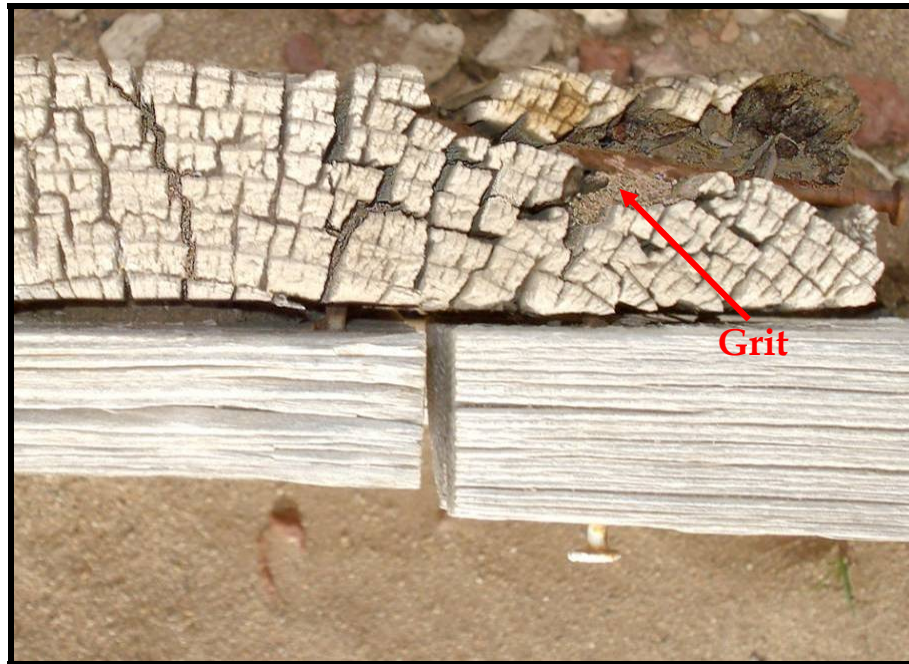
Figure 3. Detail of a grave enclosure post with weathering, showing sand and grit accumulating within the crevices.

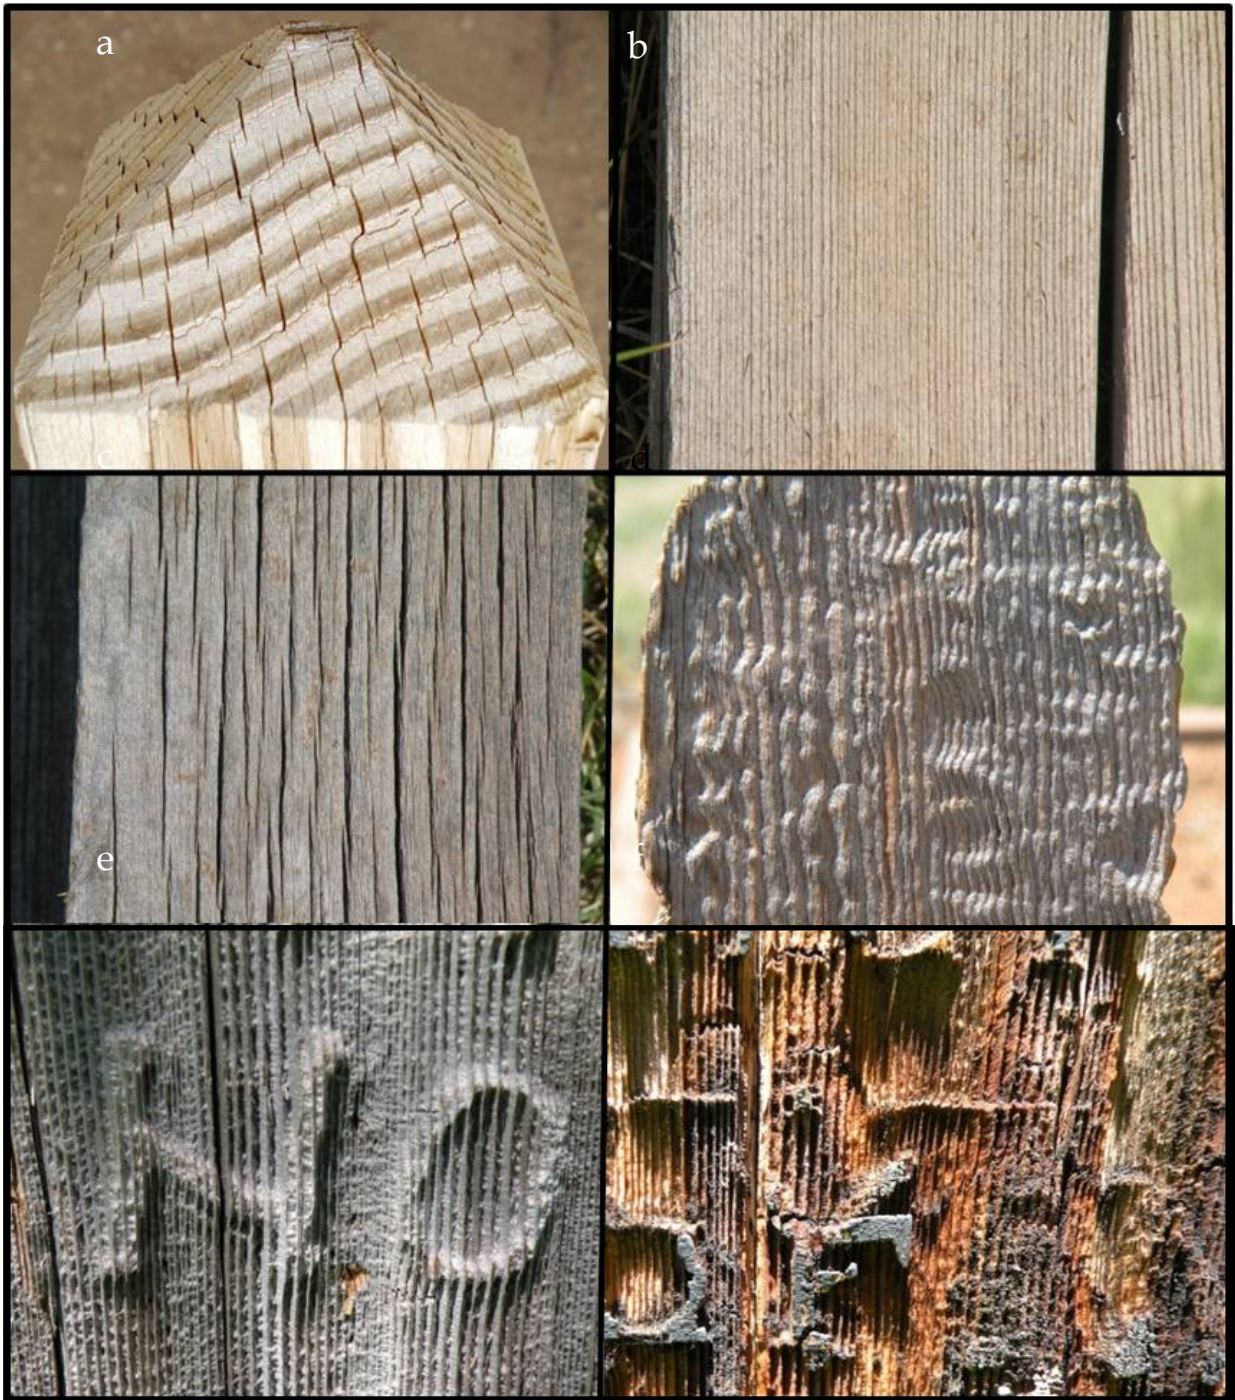
Figure 4. Examples of weathering ranging from some surface checking and slight discoloration (a through c) to extensive erosion of the softer earlywood (d through f).

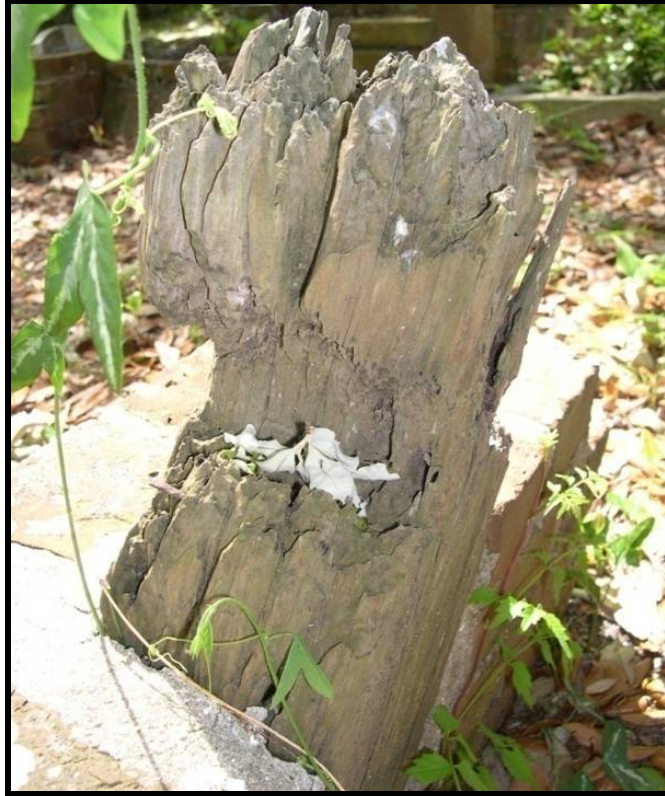
Figure 5. A small, almost unrecognizable, key-shaped foot marker with organic debris collecting within heavily weathered and insect-damaged crevices.

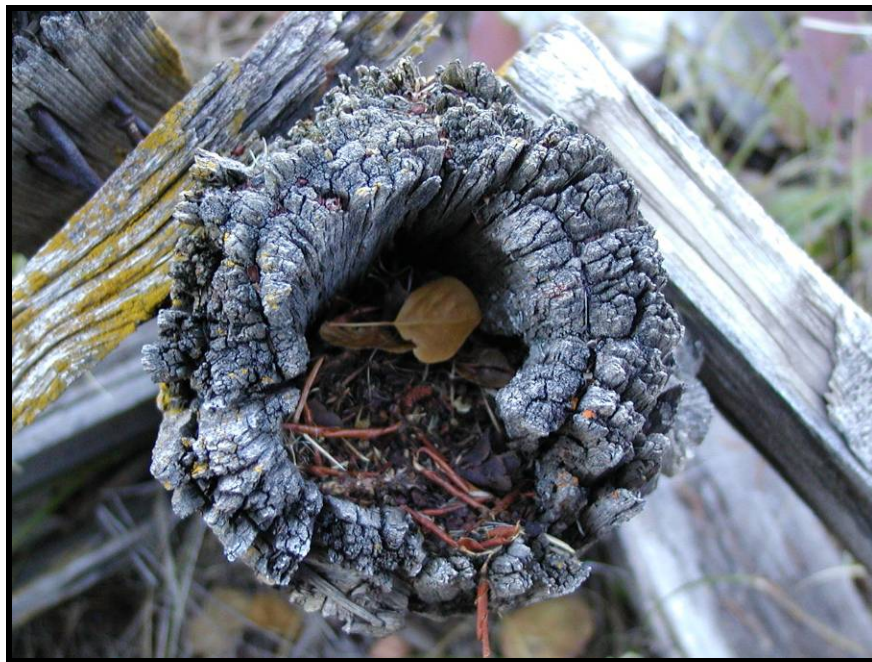
Figure 6. A grave enclosure corner post with debris collecting in a deteriorated area. This is an example of weathering that can lead to cavities susceptible to decay.

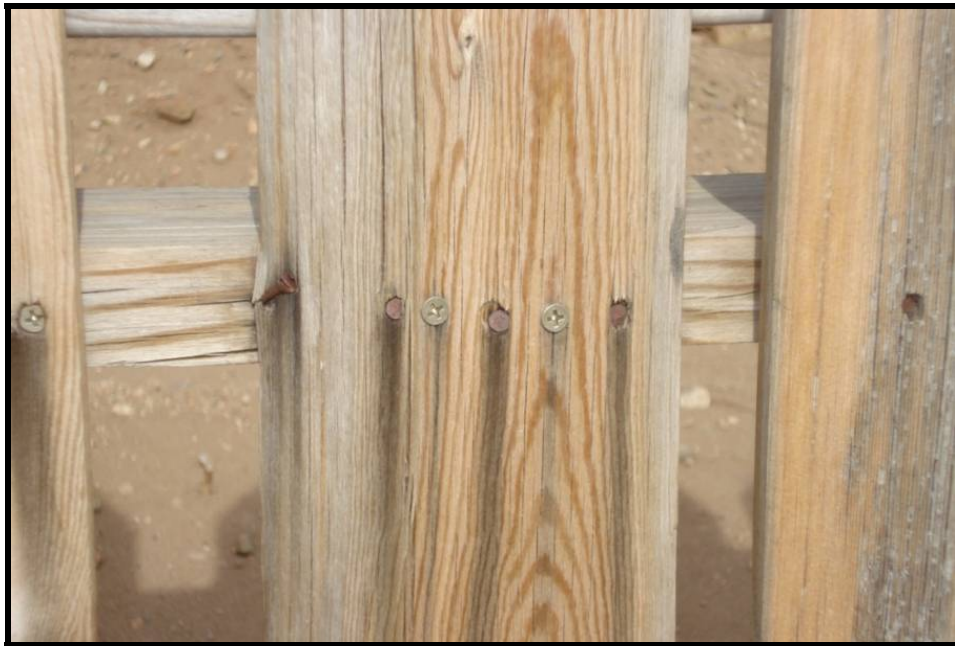
Figure 7. Stains on a grave enclosure caused by the combination of moisture and a chemical reaction between extractives in the wood and the metal fasteners.

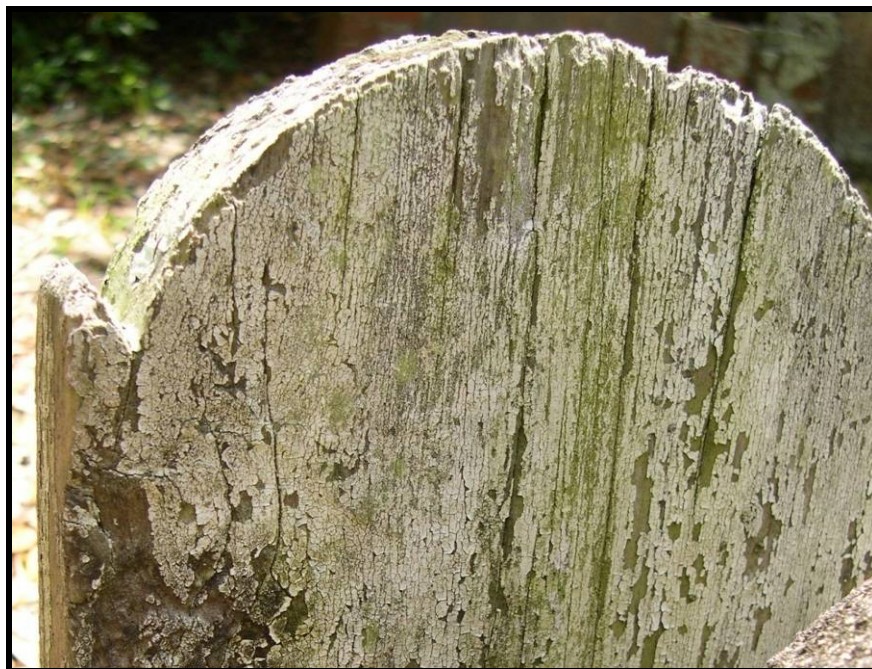
Figure 8. The back of a painted wooden grave marker with what is likely green mold growth.

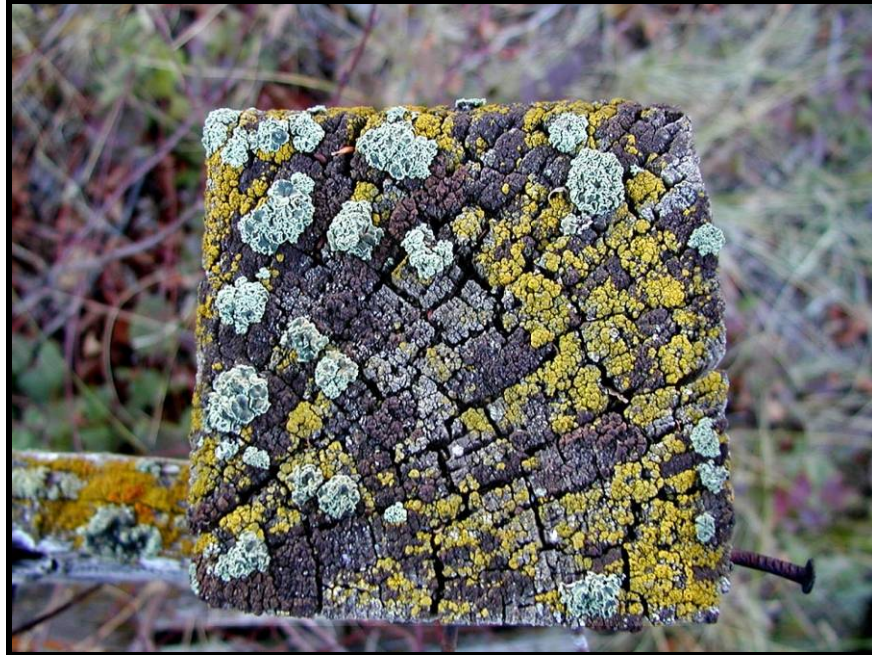
Figure 9. Lichens growing on a grave enclosure corner post.

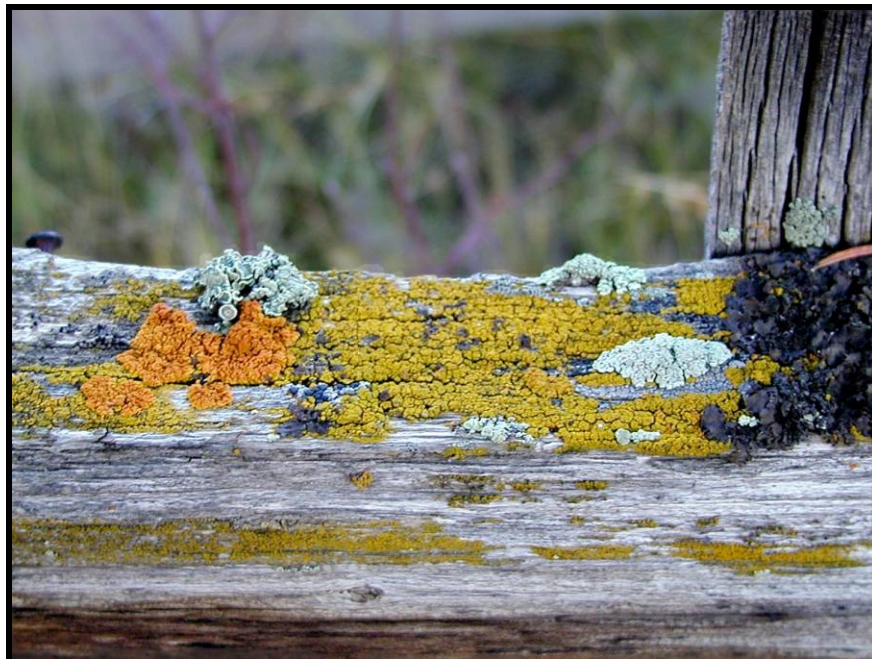
Figure 10. Crustose lichens (orange and gold) and foliose lichens (green and purple) growing on the top rail of a grave enclosure.

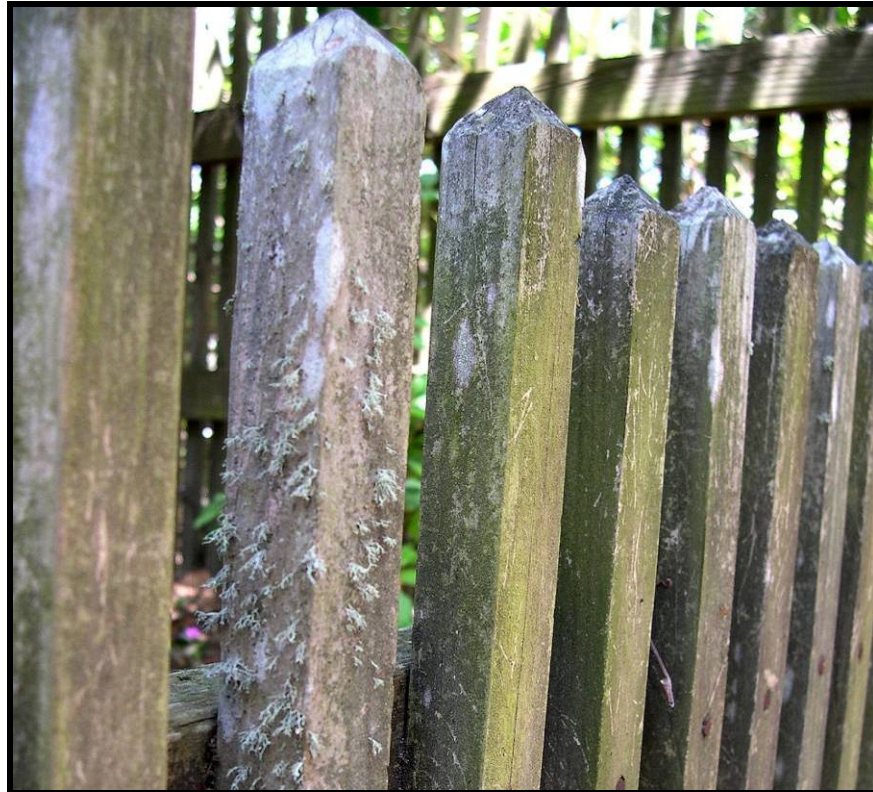
Figure 11. Fructicose lichens and green mold growing on grave enclosure pickets.

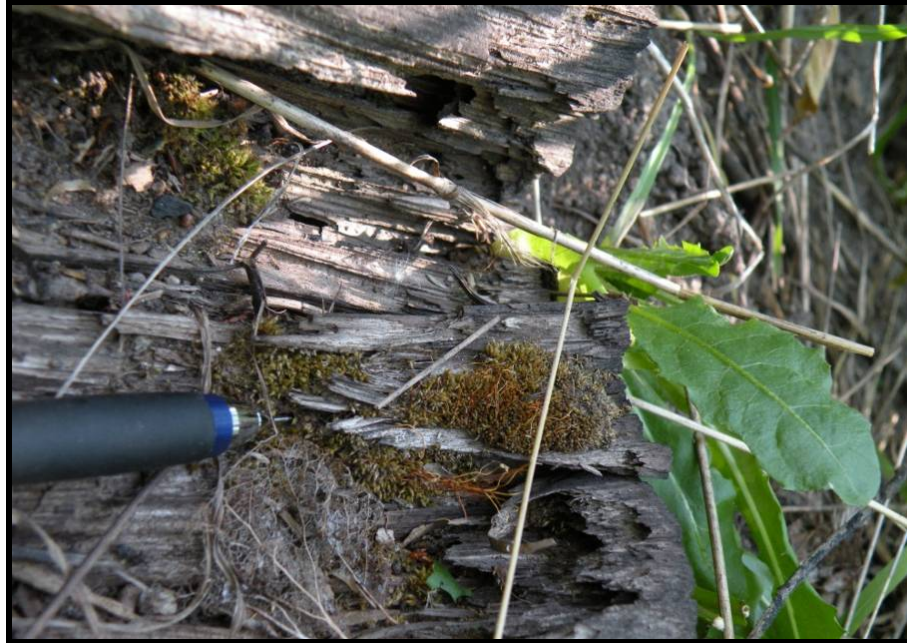
Figure 12. Moss on a grave curb. Pencil is for scale.

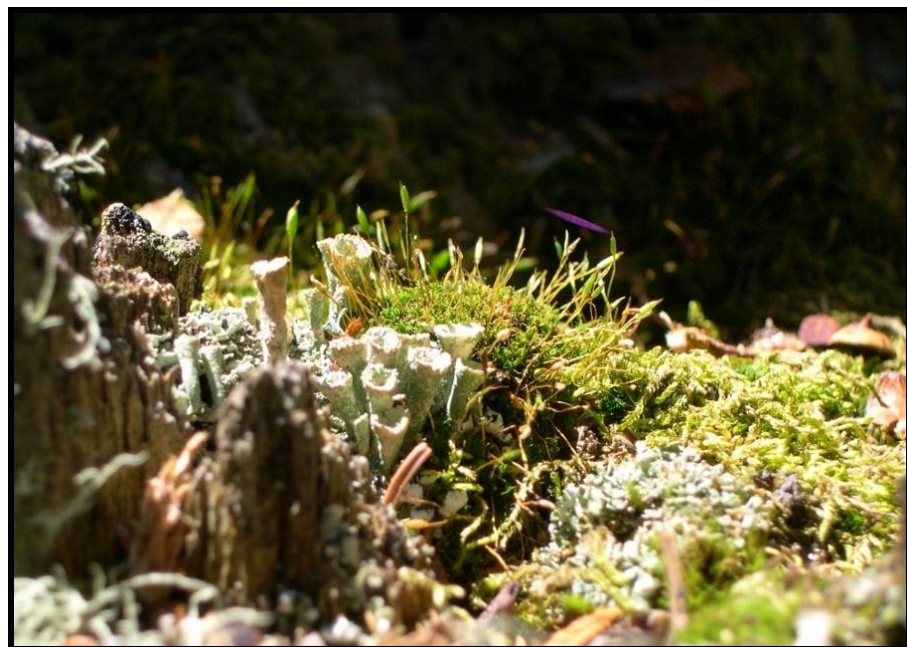
Figure 13. A variety of lichens and mosses growing on a log stump, indicating high levels of moisture and low levels of sun exposure.

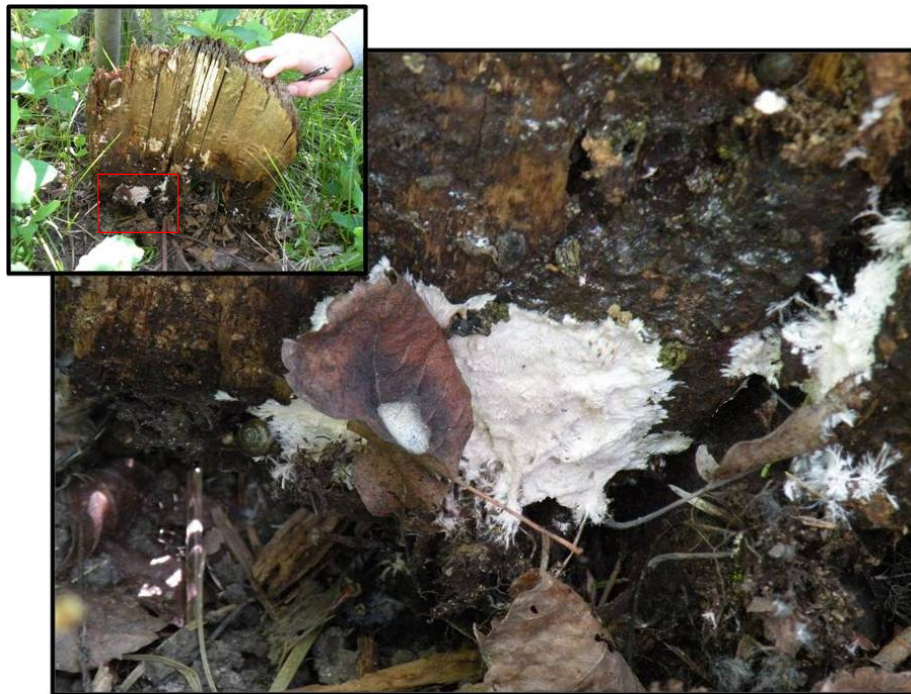
Figure 14. Cottony white fungal fruiting body found on a marker.

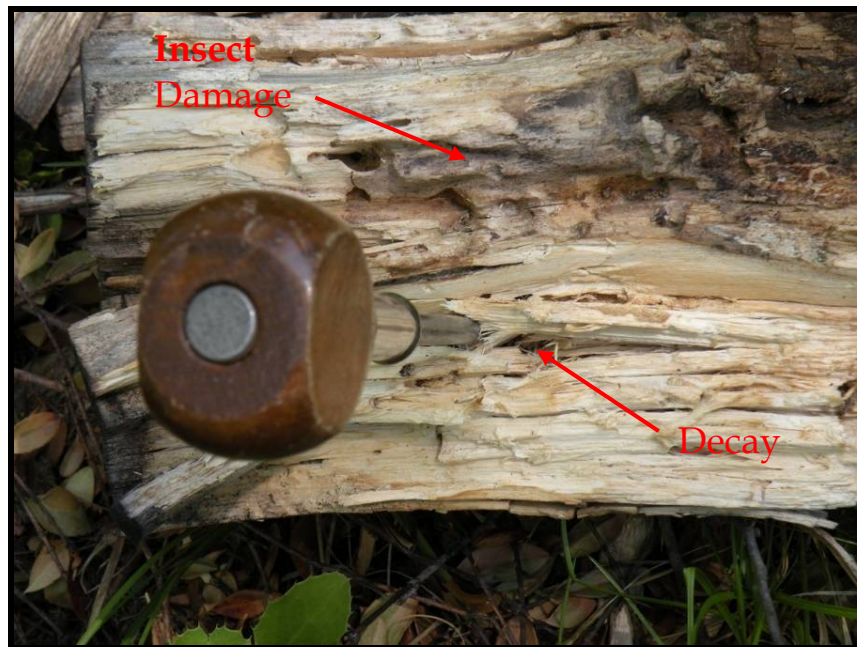
Figure 15. Example of decay (bottom half) and minor insect damage (top half) on the face of a marker at ground level. Penetration of the awl with very little applied pressure at a single location exposed the severely decayed wood.

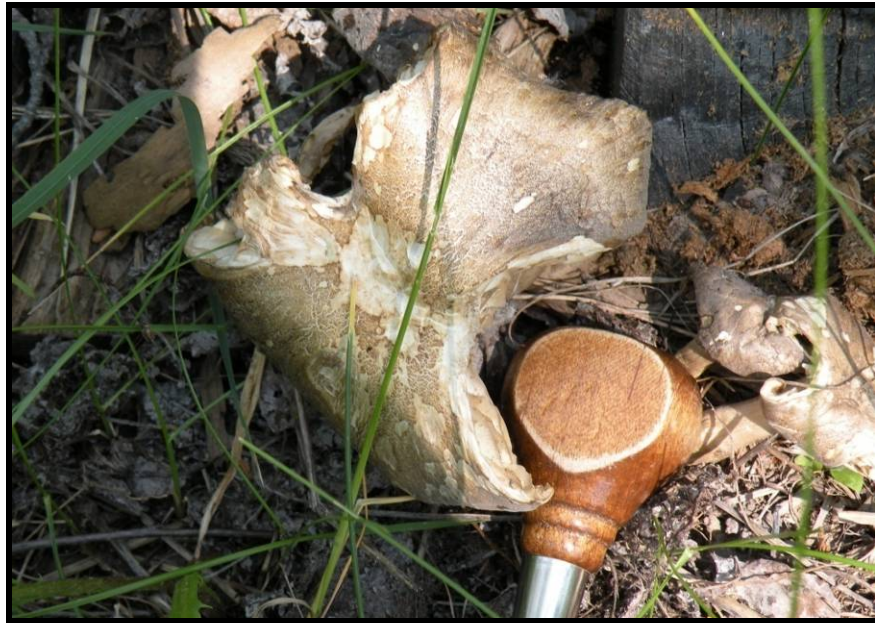
Figure 16. Fruiting body found in association with a decaying wooden marker. The 1 ½-inch diameter awl handle is shown for scale.

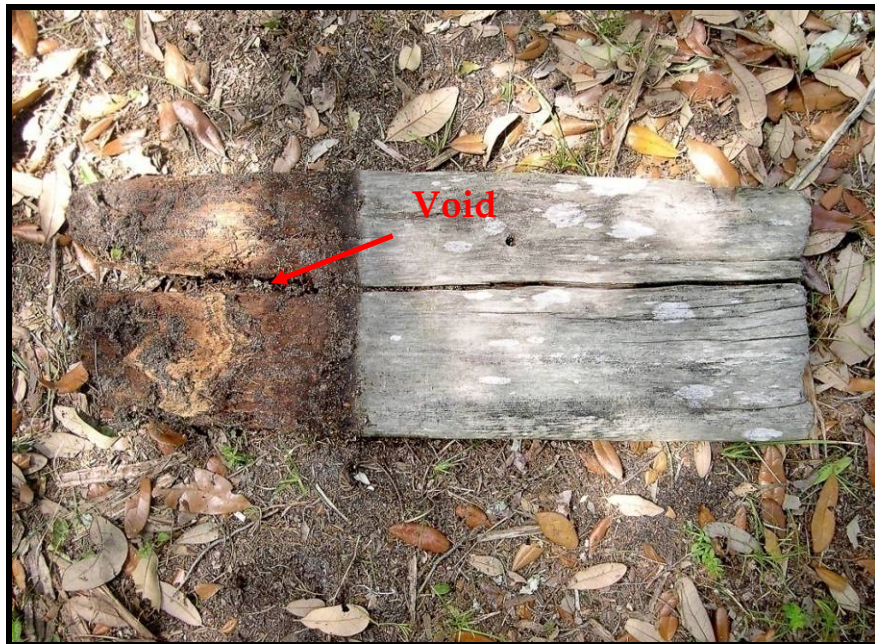
Figure 17. An example of moisture wicking along the grain of a grave marker that has allowed the growth of decay fungi and ultimately resulted in a void below ground as the decay progressed. Note: this marker was removed from the ground for research purposes. Removing artifacts from the ground for assessment is not recommended.

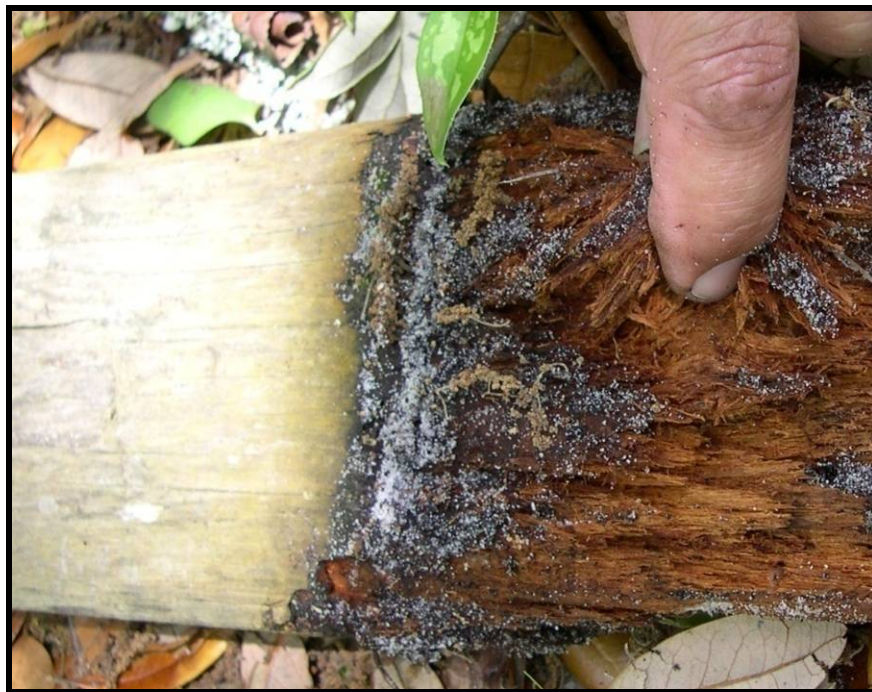
Figure 18. Evidence of advanced decay – the below-ground portion of this marker is punky and easily breaks apart.

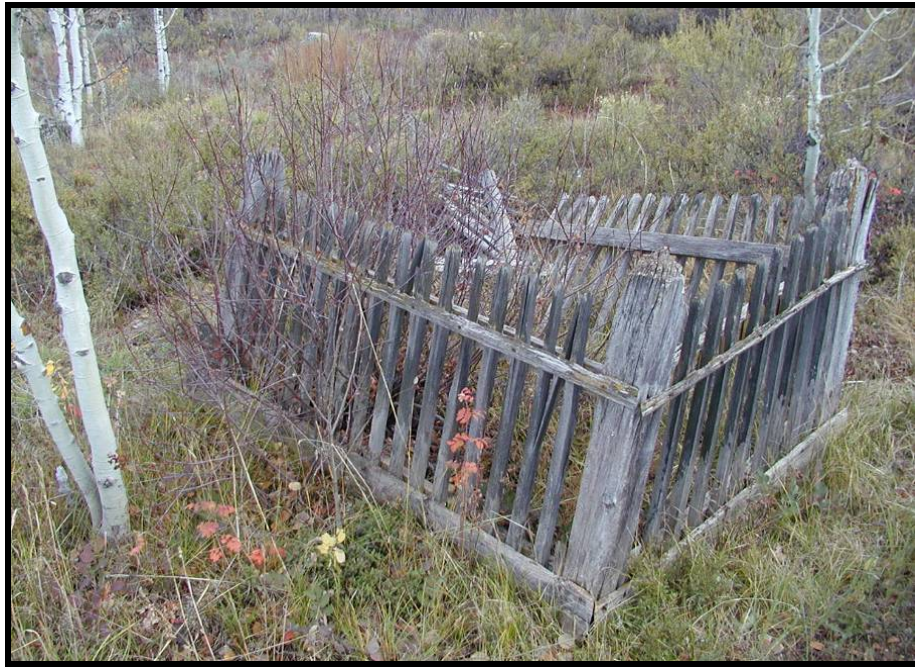
Figure 19. A grave enclosure in partial collapse due, in part, to decay of the corner posts at ground level.

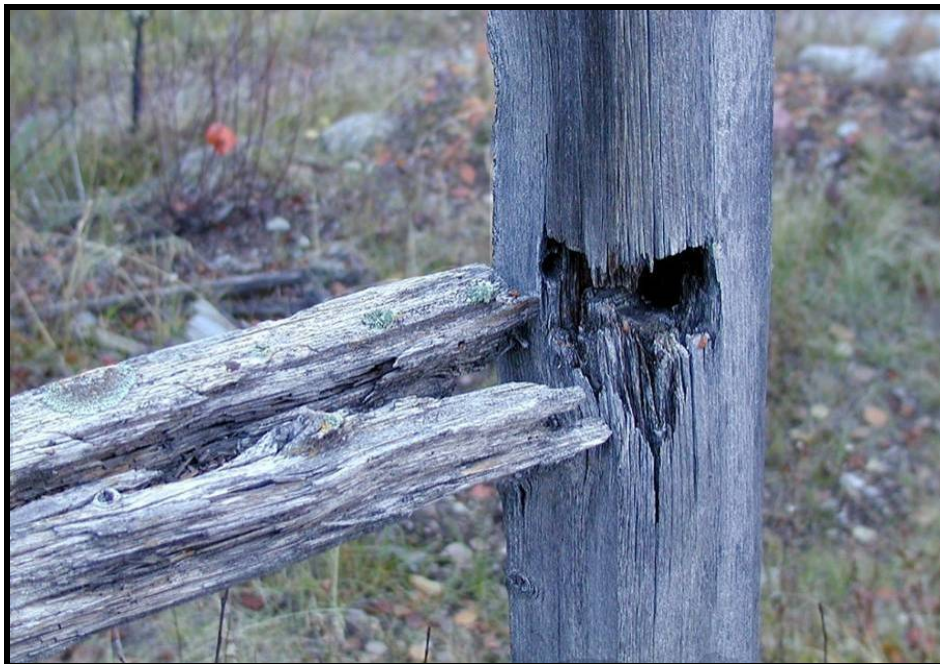
Figure 20. A grave enclosure corner post with signs of advanced internal decay and failure of a cross-member.

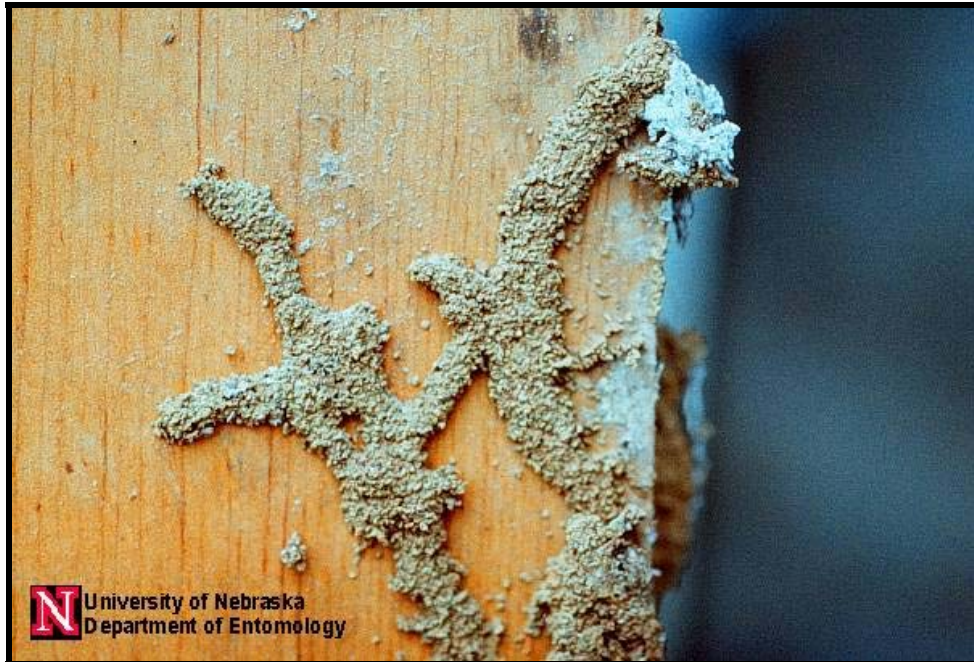
Figure 21. Subterranean termite mud tubes on lumber (Keith, 2000).

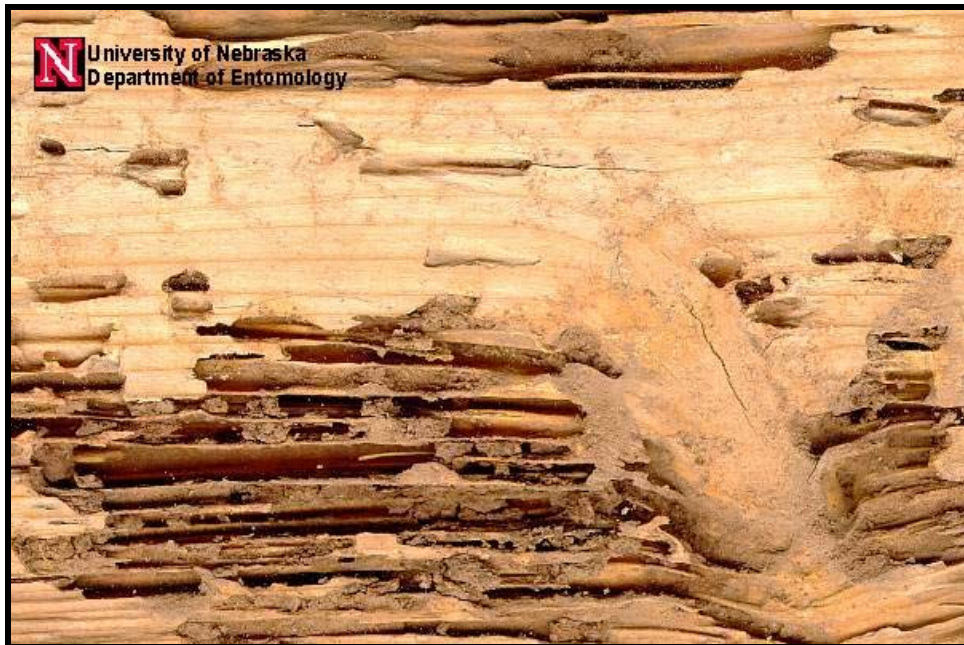
Figure 22. Subterranean termite damage in pine. Note the mud packed within the galleries (Kalisch 2000).

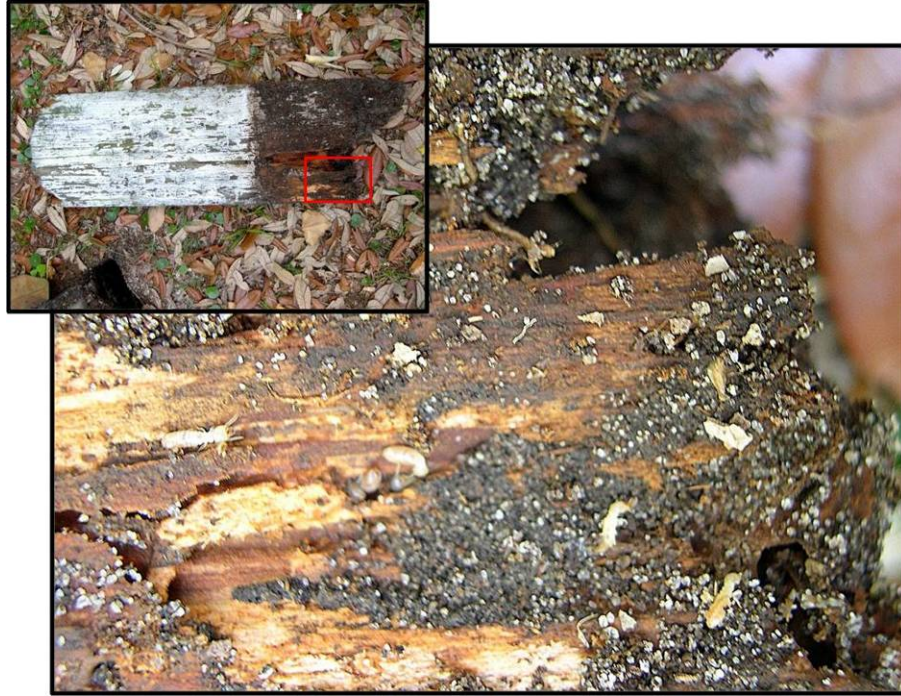
Figure 23. Subterranean termites found on the in-ground portion of a wooden grave marker.

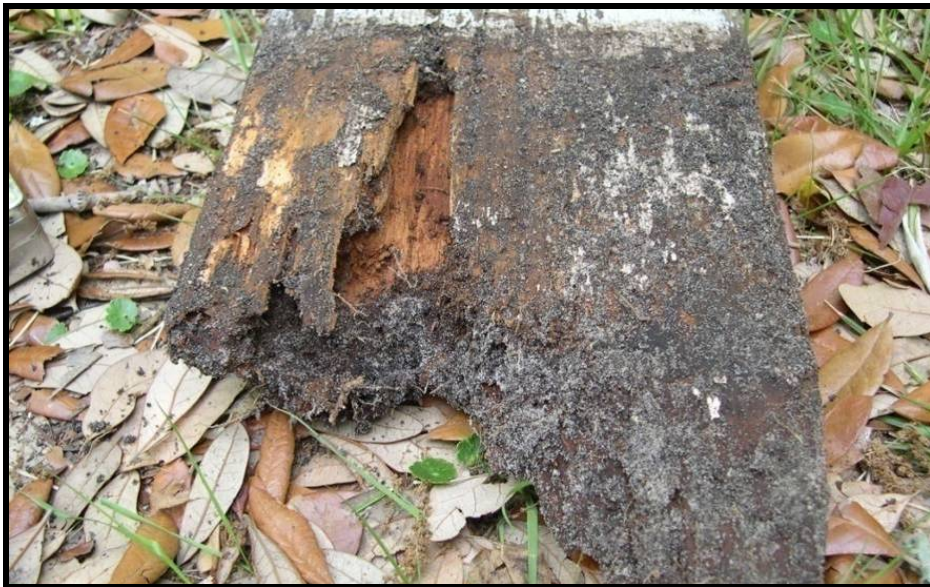
Figure 24. Loss of wood in the underground portion of a grave marker by subterranean termites.

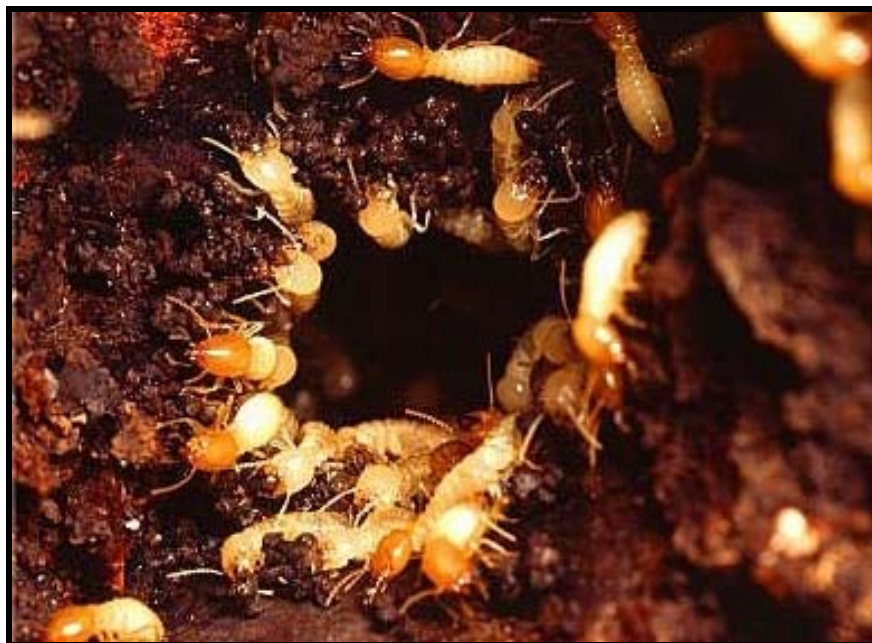
Figure 25. Aggressive Formosan subterranean termites (magnified 400 percent) found in Hawaii and many southern regions of the United States (Bauer 2003).

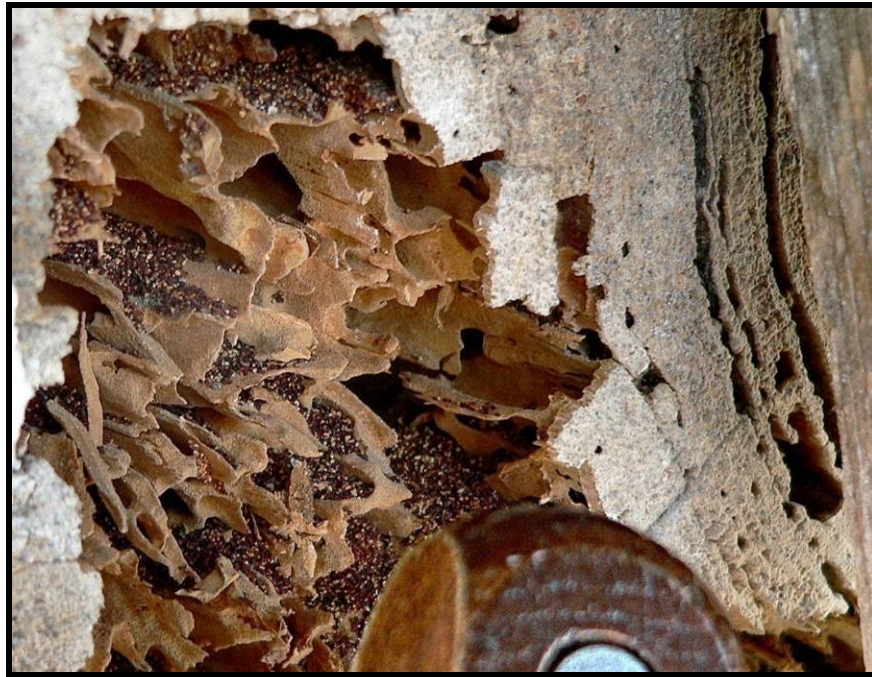
Figure 26. Typical drywood termite galleries discovered after breaking through a thin shell of sound-looking wood. Note the collection of fecal pellets. Awl handle in foreground is shown for scale.

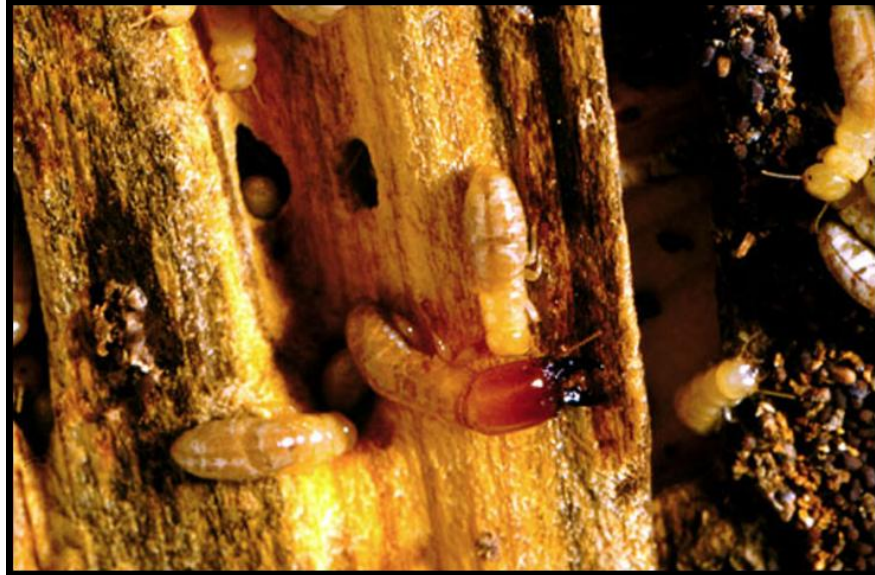
Figure 27. Dampwood termites (magnified 150 percent). Note the amorphous clumps of fecal pellets, left (Scheffrahn and Su 2000).

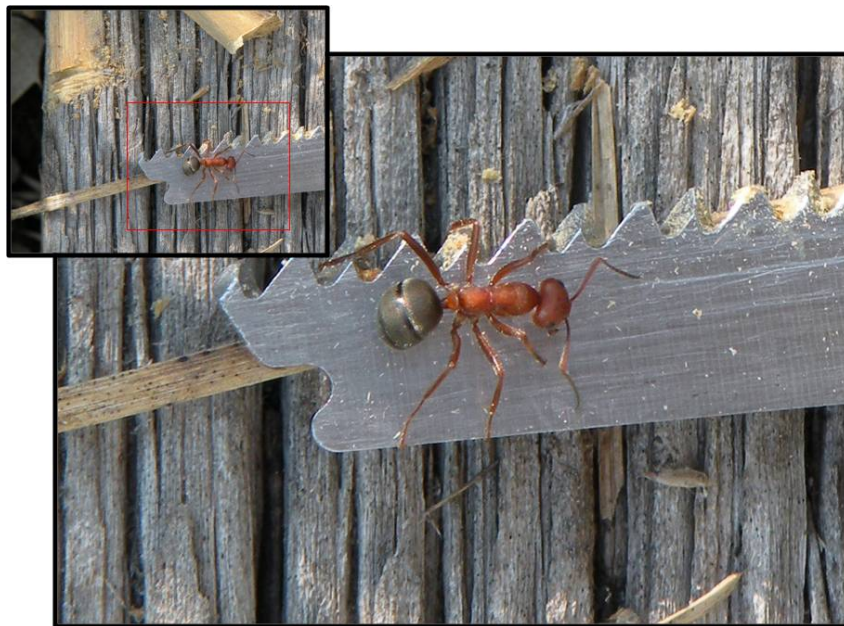
Figure 28. Detail of a carpenter ant. Saw blade is for scale.

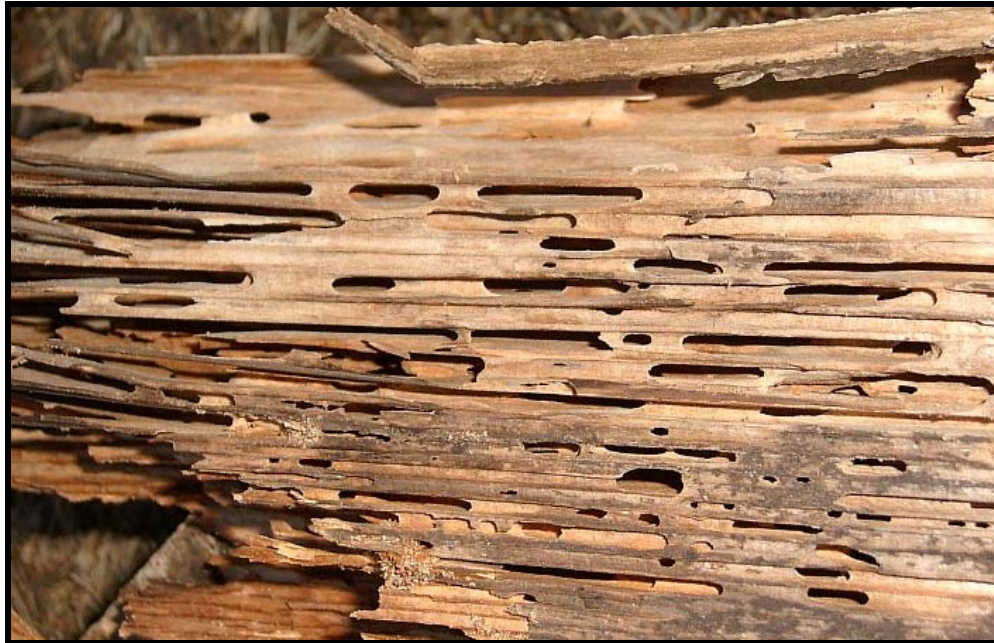
Figure 29. A wood truss with severe carpenter ant damage (Fritsche 2005).

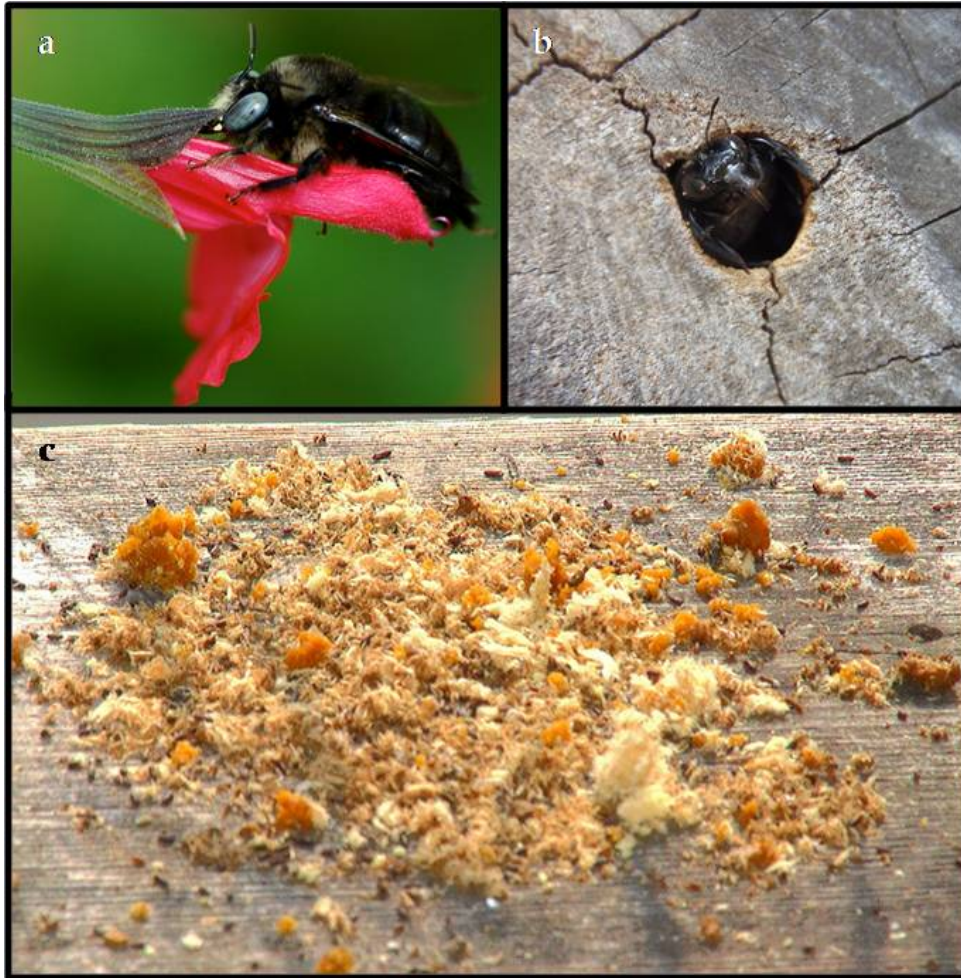
Figure 30. Carpenter bees. Image (a) is of a male carpenter bee (Witsch 2006), image (b) shows a female carpenter bee within her nest (Zinkova 2007), and image (c) shows the frass generated by the bees' wood-boring activity (PixOnTrax 2007).

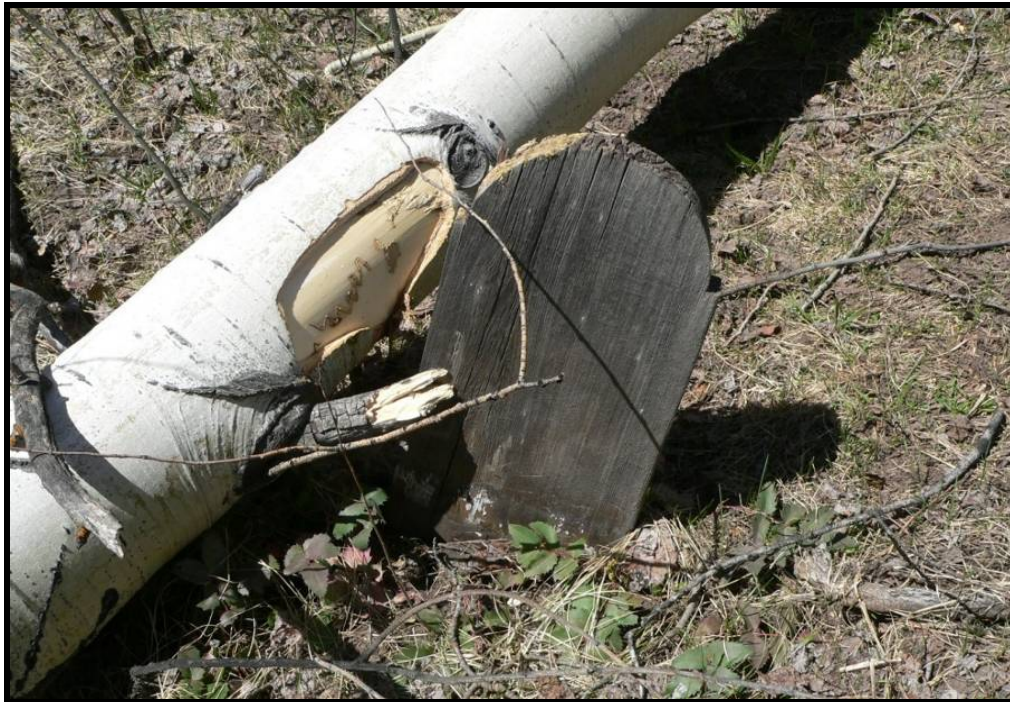
Figure 31. A fallen tree grazed this marker on the way down, damaging the top of the marker and pushing it partially out of the ground.

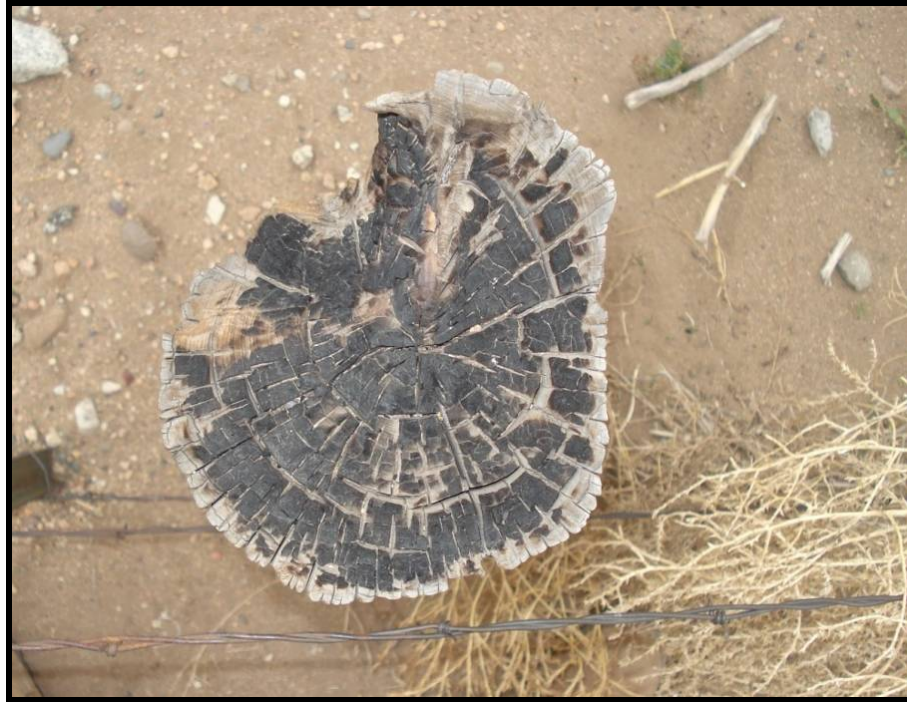
Figure 32. A cemetery fence post damaged by fire.

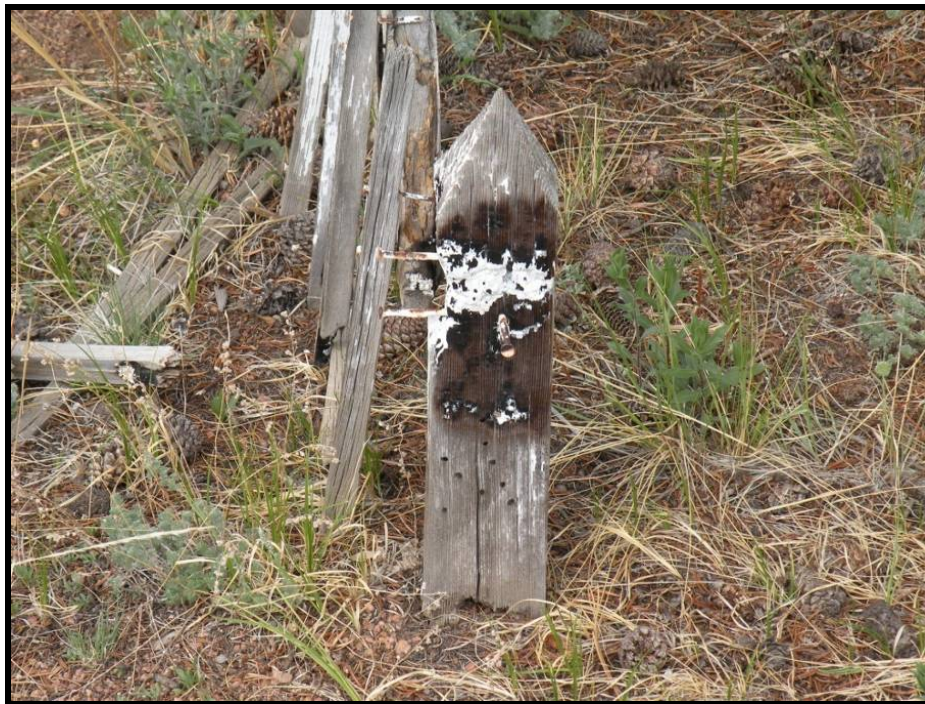
Figure 33. A grave enclosure corner post damaged by fire.

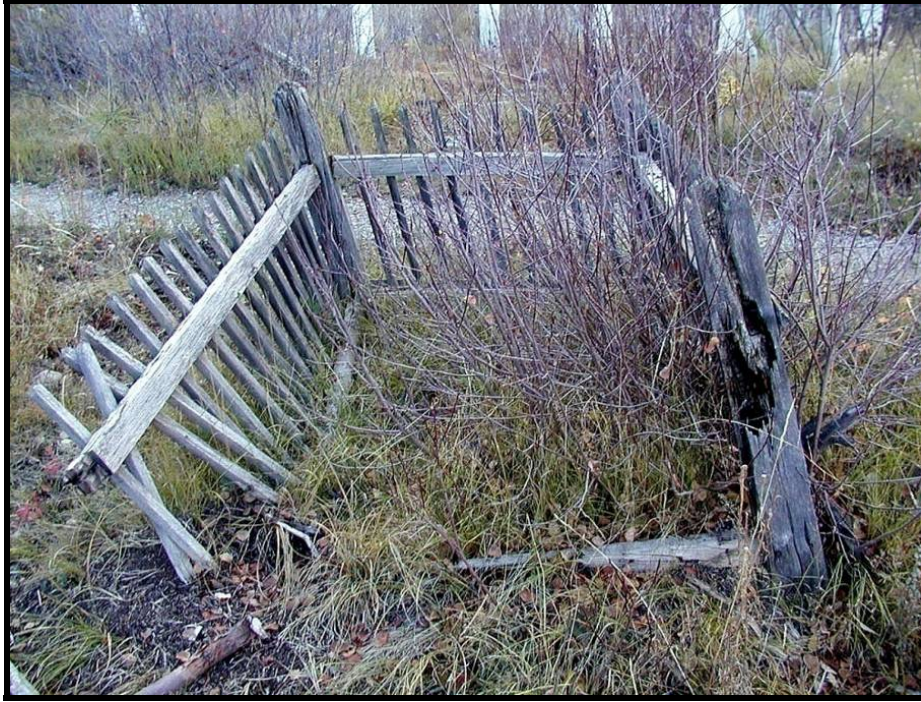
Figure 34. A grave enclosure damaged by overgrowth of an invasive shrub in combination with decay of the corner posts.
