Wooden Artifacts in Cemeteries

A Reference Manual

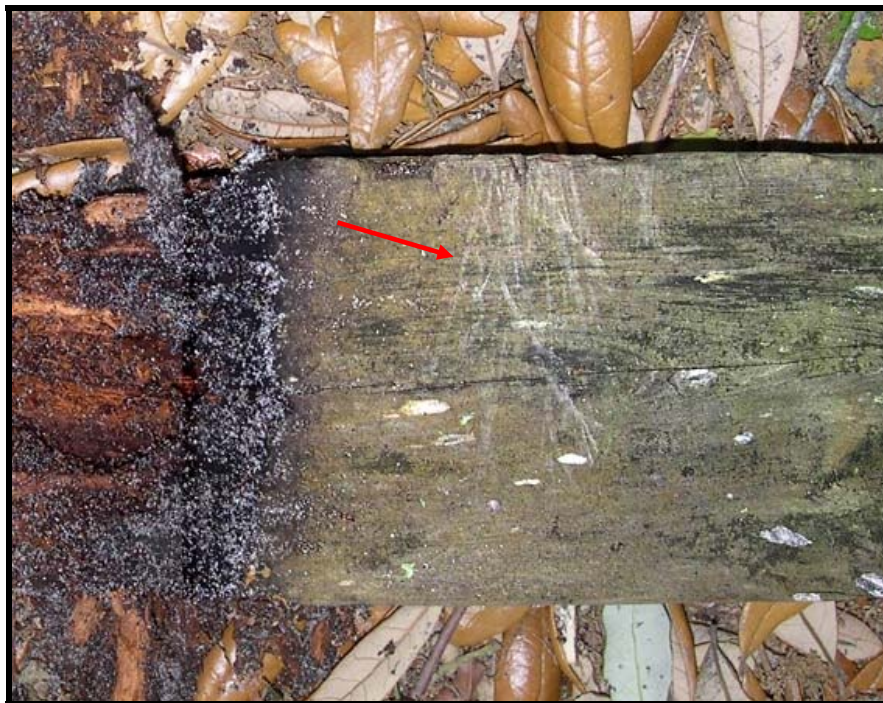
Figure 35. A grave marker showing damage from a weed trimmer. This marker was removed from the ground during research. Removing artifacts from the ground is not recommended.

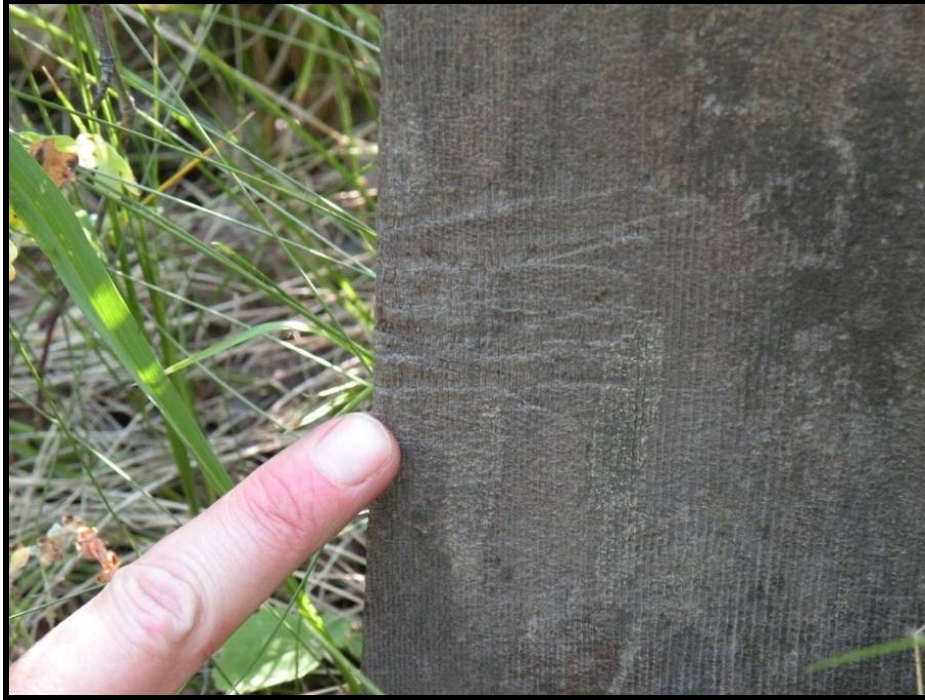
Figure 36. Damage on the edge of a wooden marker caused by a weed trimmer.

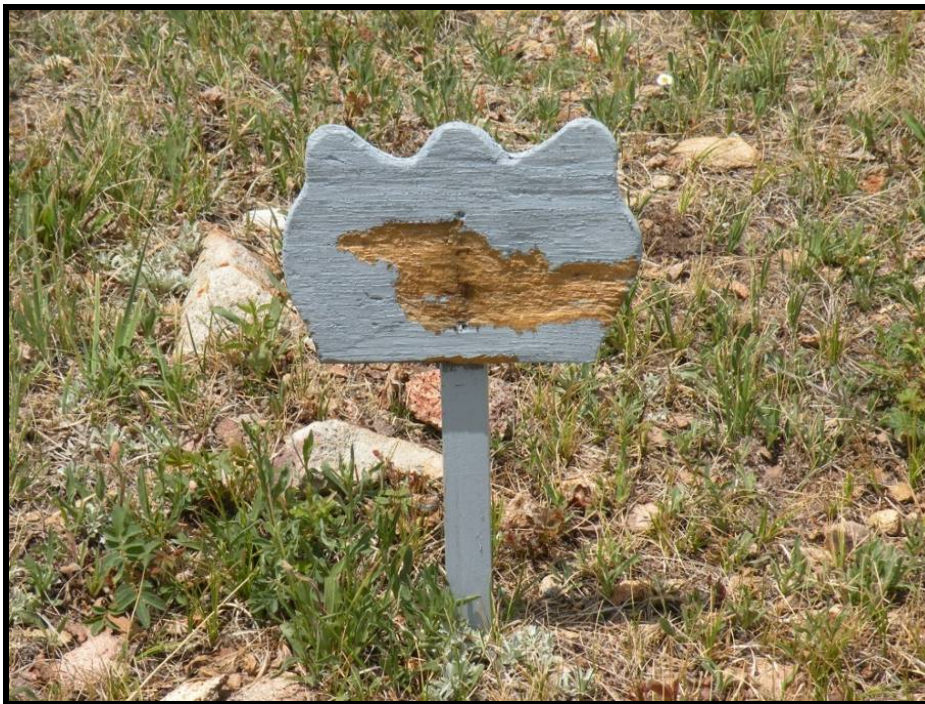
Figure 37. A wooden plaque marking a grave with the surface chewed off by animals.

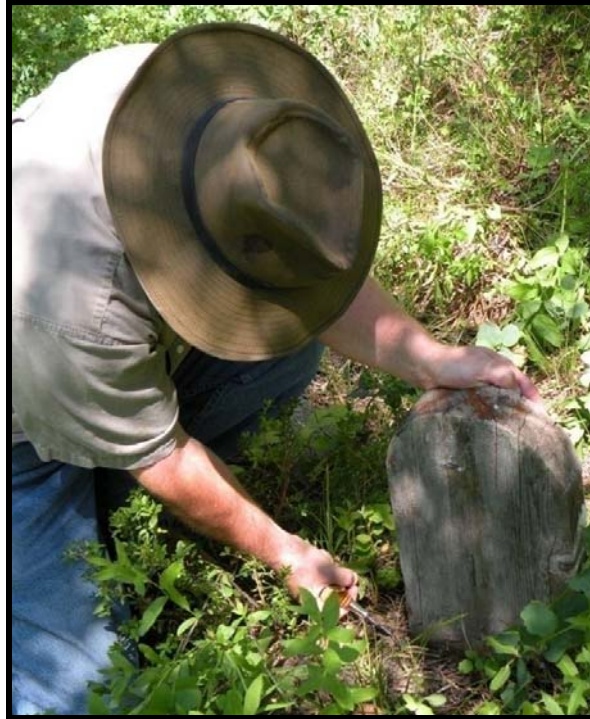
Figure 38. Probing at the base of a marker with an awl to check for deterioration.

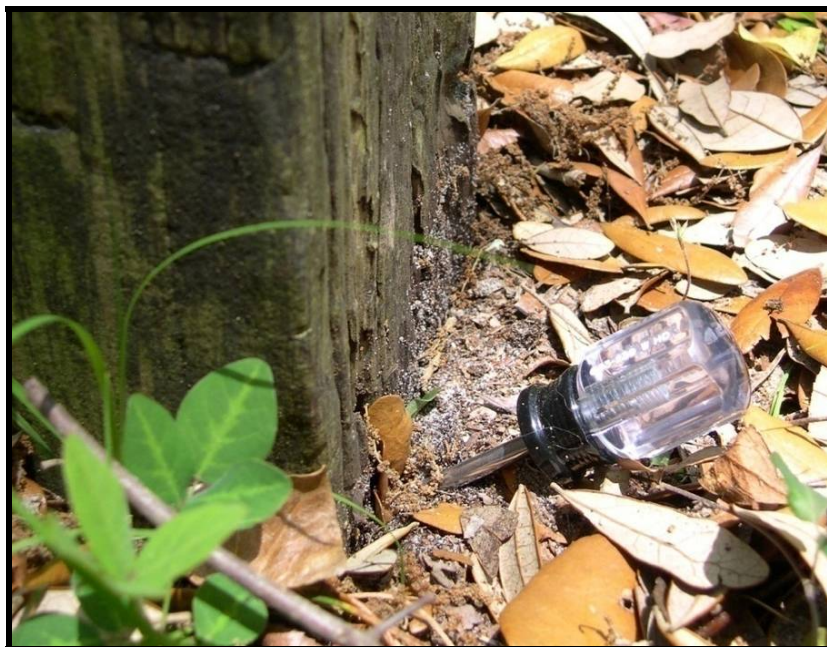
Figure 39. An awl at the base of a grave marker. Based on the length of penetration, this marker has approximately 1/2-inch of punky wood below the ground surface.

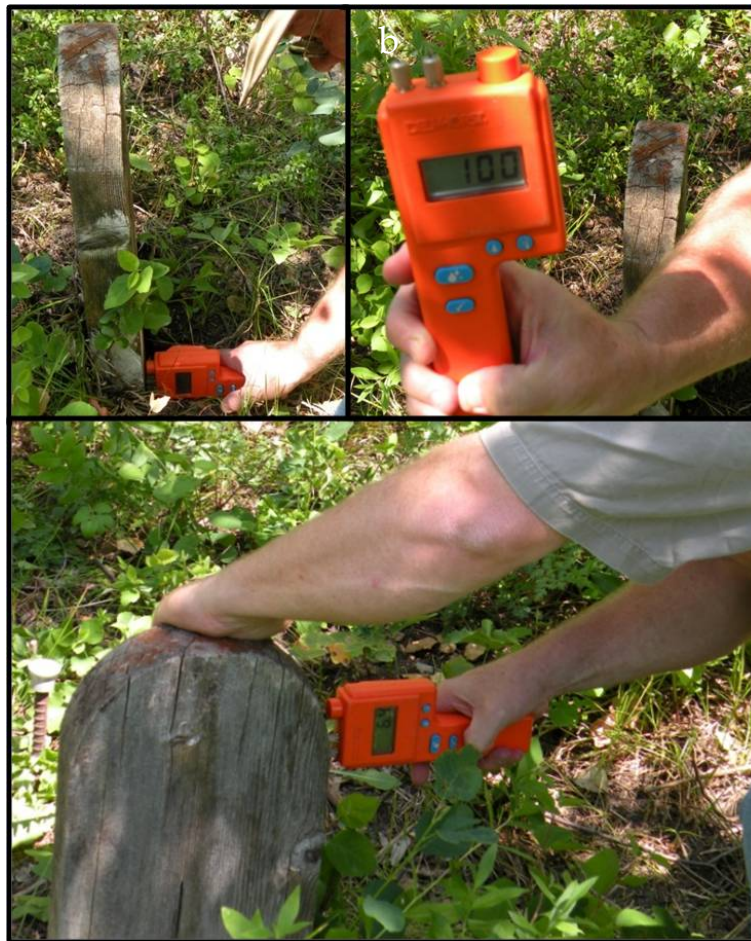
Figure 40. Taking moisture readings on a grave marker using a resistance-type meter. Image (a) shows a reading being taken at the base of the marker; (b) shows the digital readout of 10 percent; (c) shows another reading being taken at the top of the marker (where the moisture content reads 6 percent).

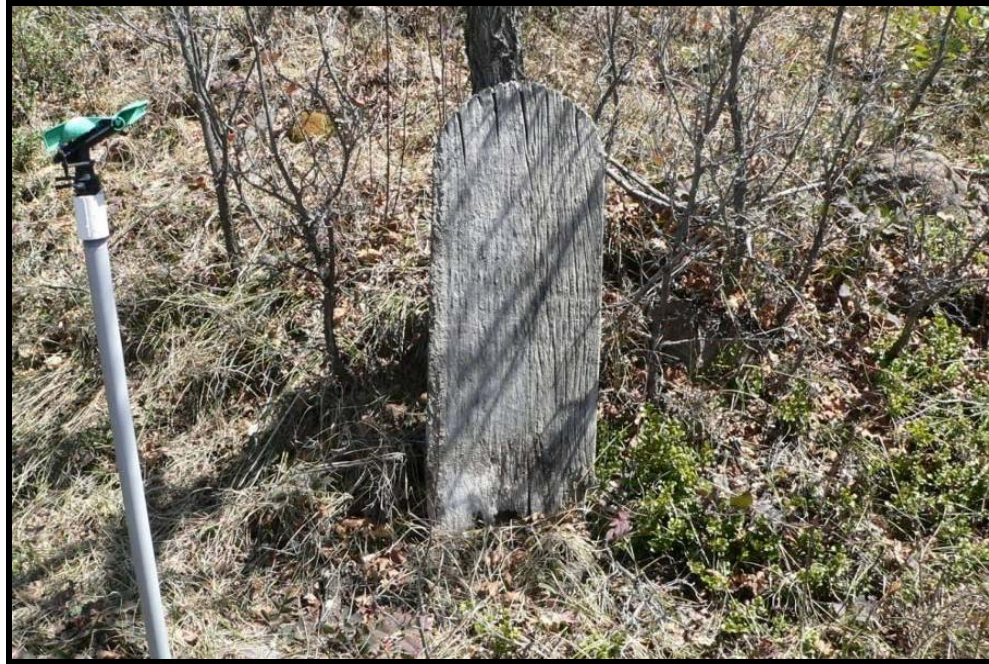
Figure 41. A water sprinkler located directly next to a wooden marker that is showing signs of decay at the base.

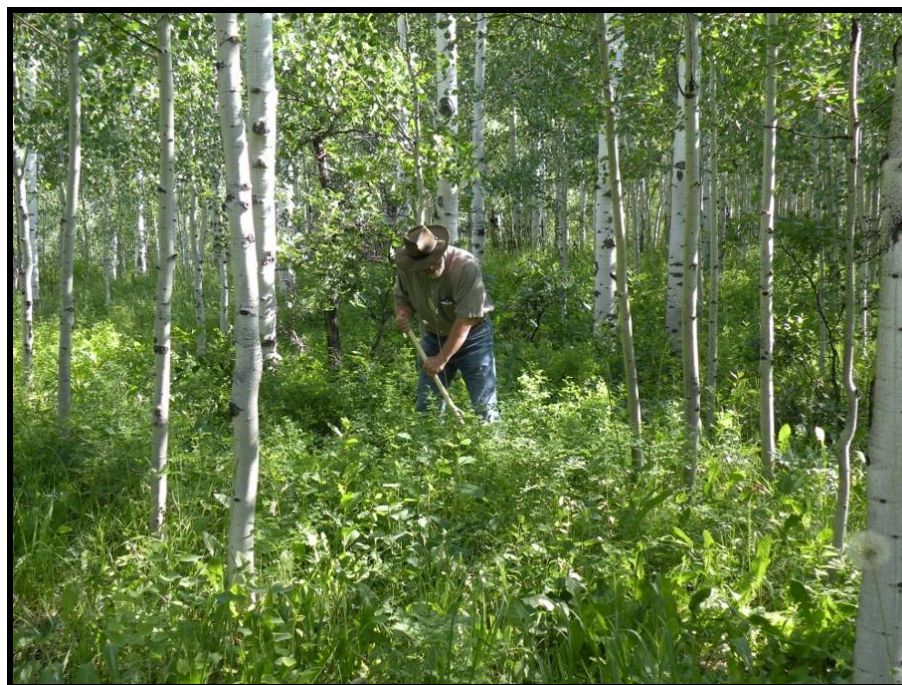
Figure 42. The vegetation in this cemetery is so dense that a rake must be used to search the ground for markers.

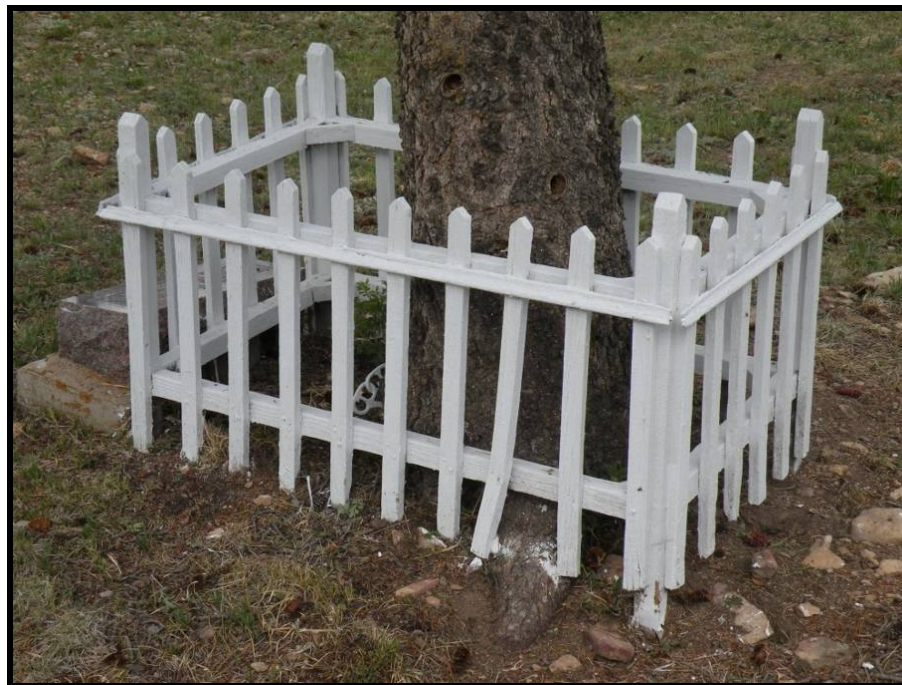
Figure 43. A freshly painted grave enclosure. Note the deformed pickets due to the tree root growth.

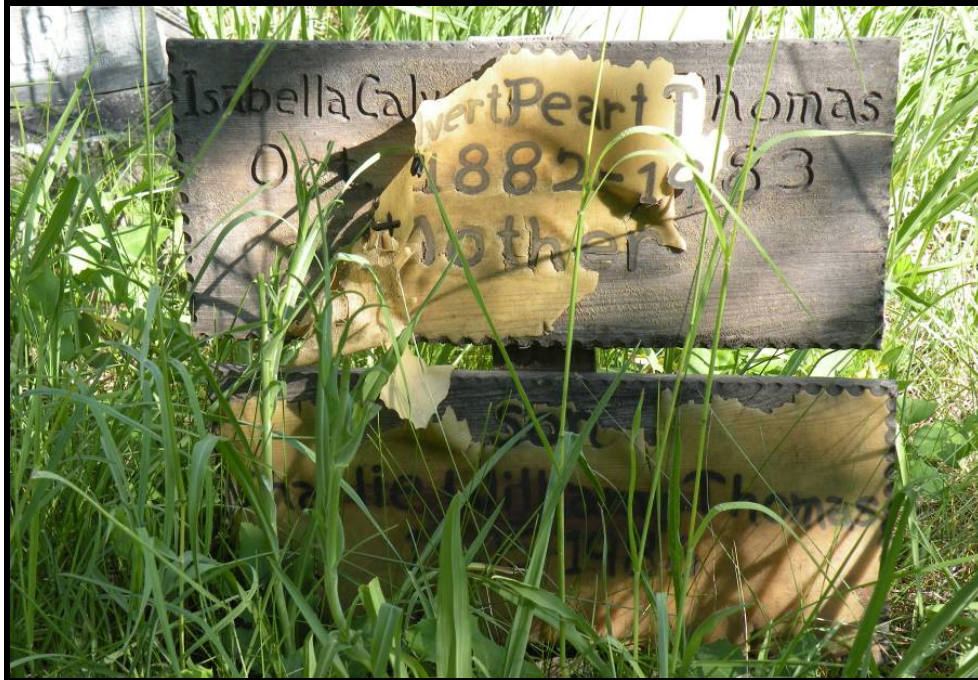
Figure 44. Failure of a transparent, film-forming finish, likely varnish or polyurethane.

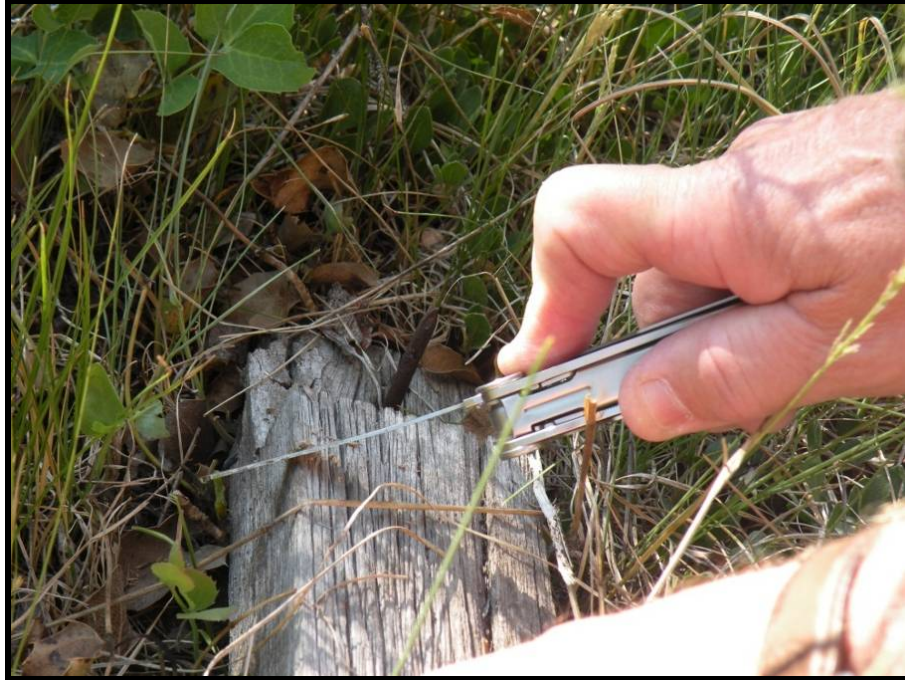
Figure 45. Cutting a sample from a grave enclosure rail.

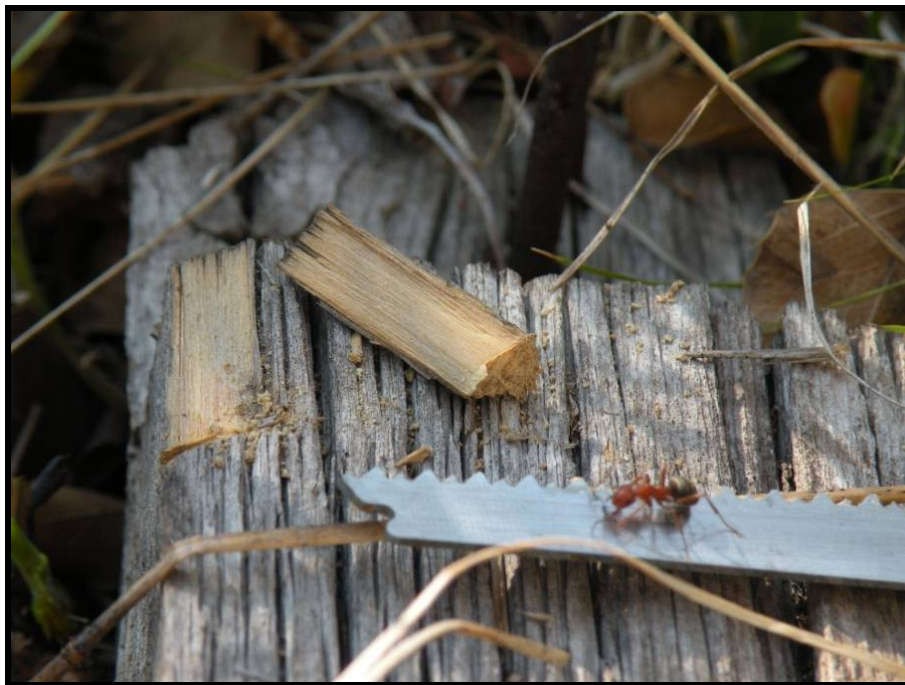
Figure 46. The sample after removal from the enclosure rail. Ant and saw blade are for scale.

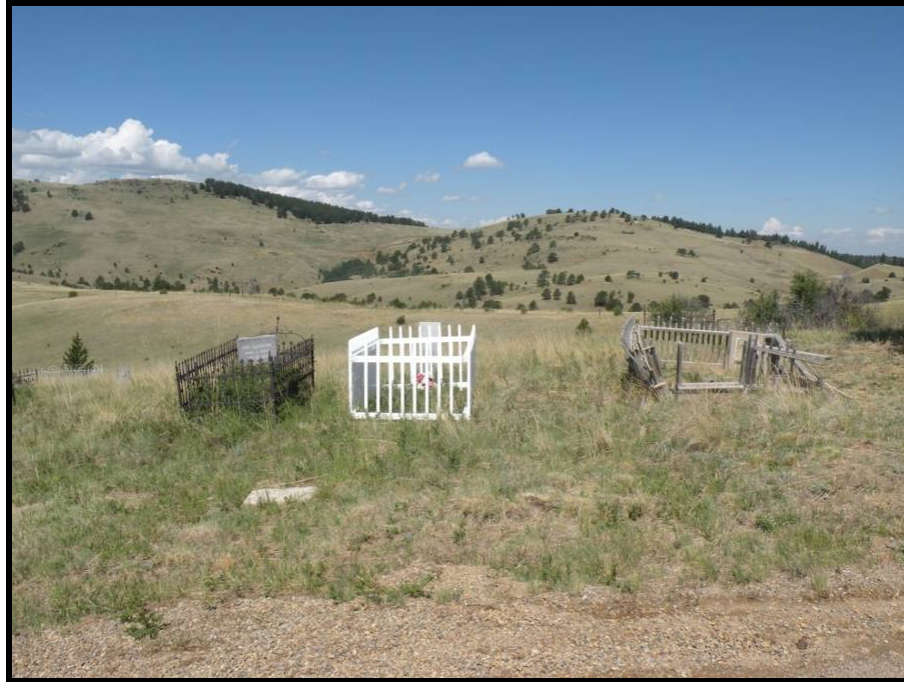
Figure 47. Historic wrought iron and wooden grave enclosures flanking an out-of-place grave enclosure made out of vinyl.

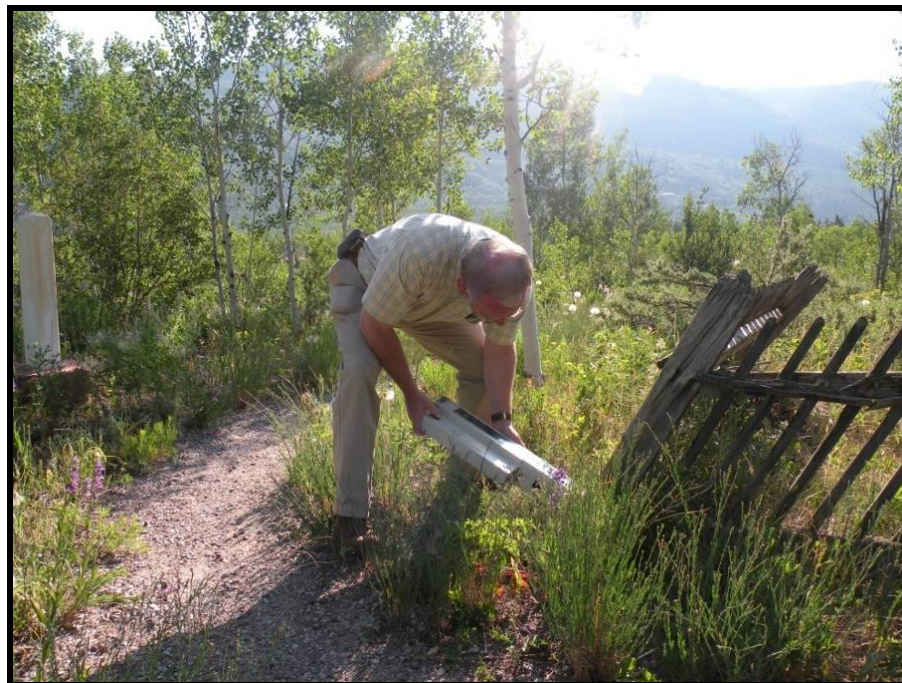
Figure 48. Resistance drilling a corner post of a wooden grave enclosure.

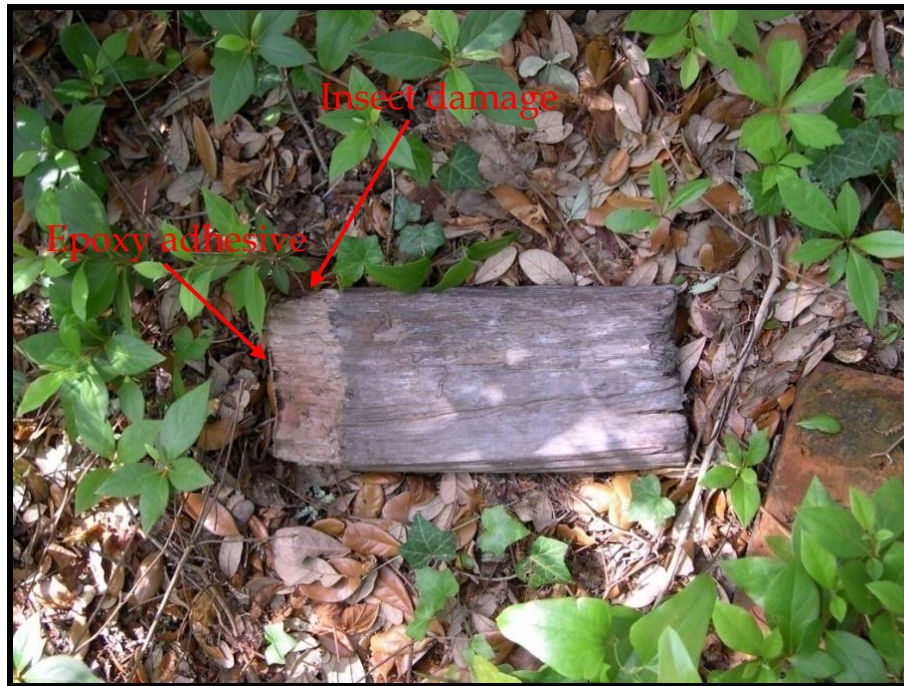
Figure 49. A previously repaired grave marker that has failed and is no longer in situ.

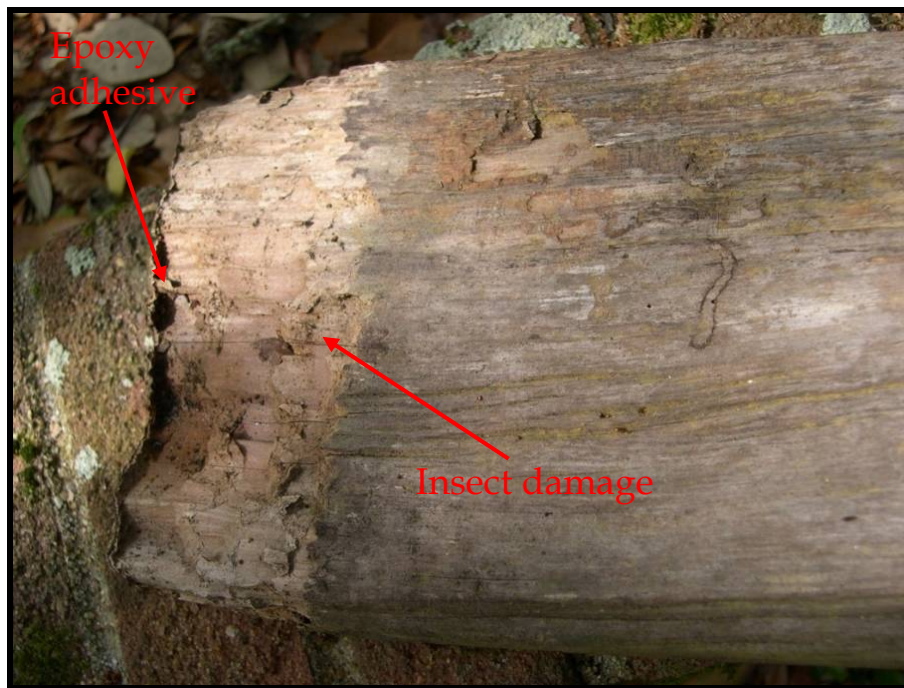
Figure 50. A detail of the repaired end of the marker in Figure 49; the epoxy remains even though the below ground portion of the marker has deteriorated.

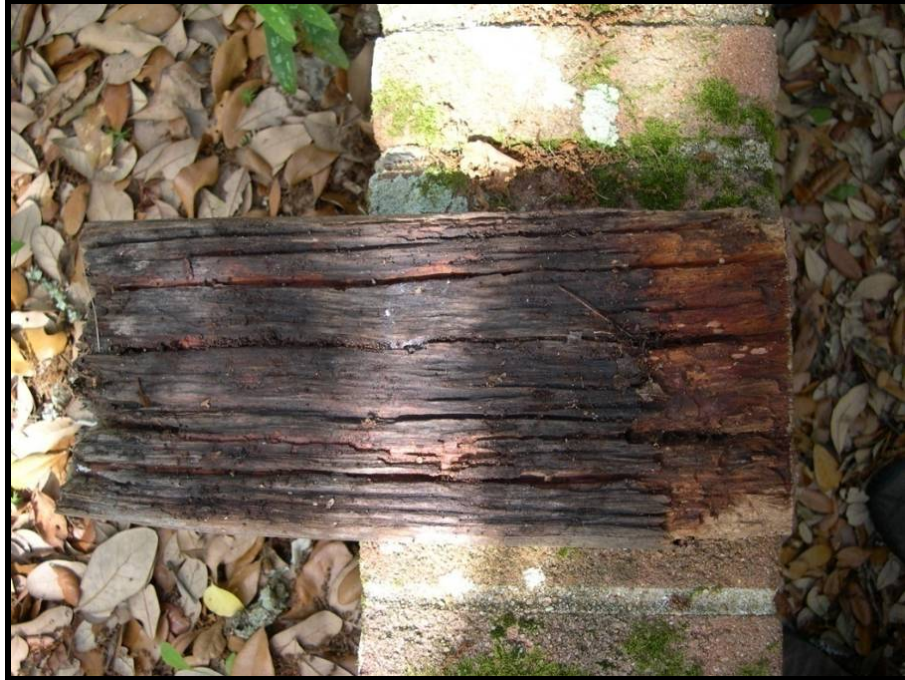
Figure 51. The back side of the same grave marker from Figures 49 and 50. This side was in ground contact and is significantly deteriorated after an unknown length of time on the ground.

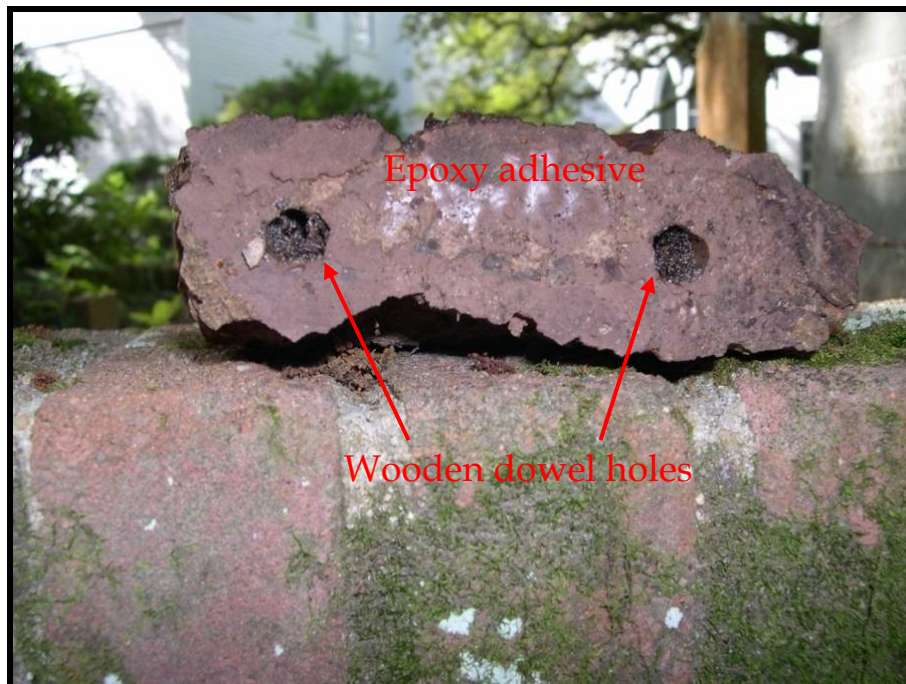
Figure 52. The repaired end of the marker (from Figures 49, 50, and 51) shows that the epoxy remains but the wooden dowels have rotted away.

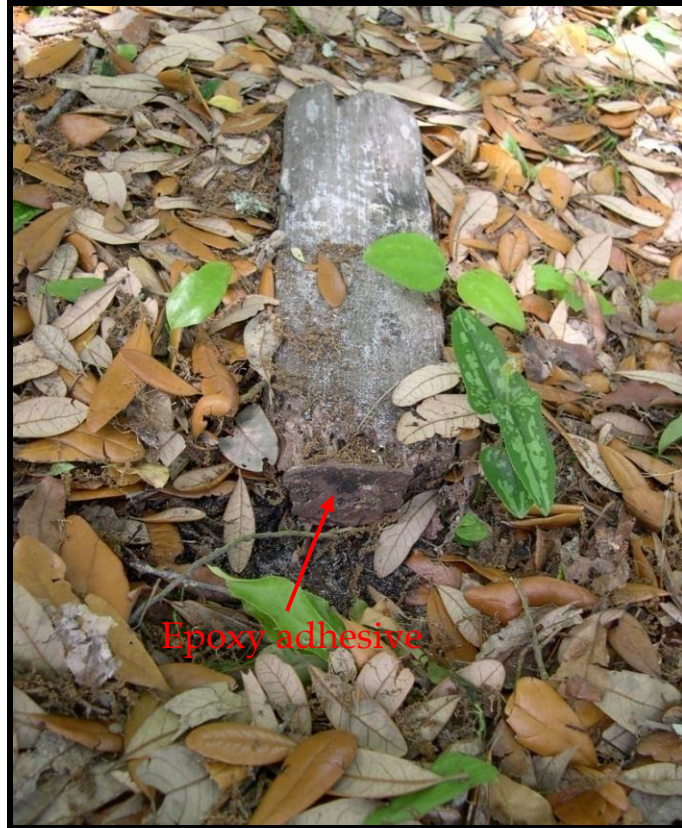
Figure 53. Another grave marker with a repair that has failed and is no longer in situ.

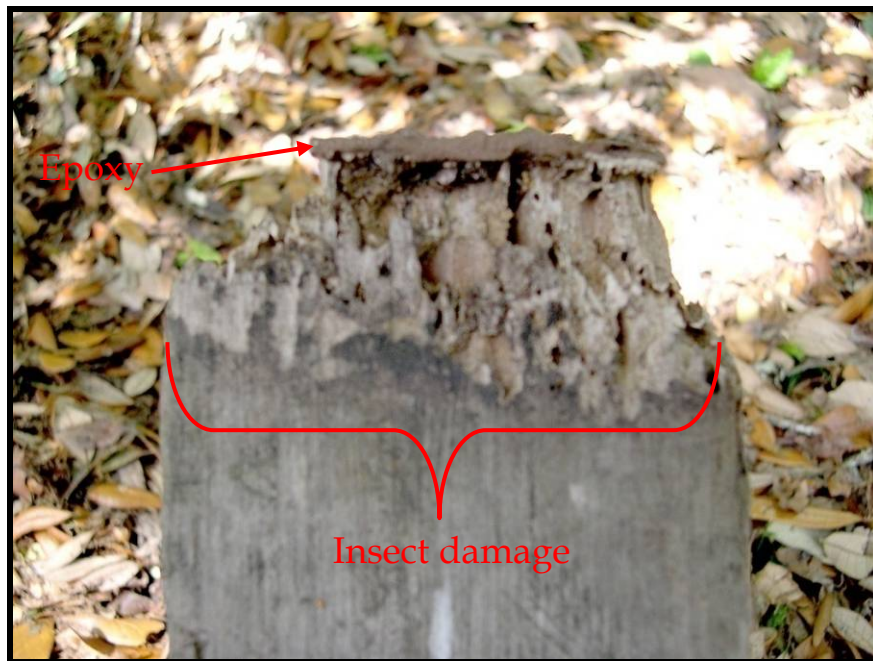
Figure 54. The repaired end of the marker from Figure 53 shows evidence of subterranean termites and epoxy that remains despite the degradation.

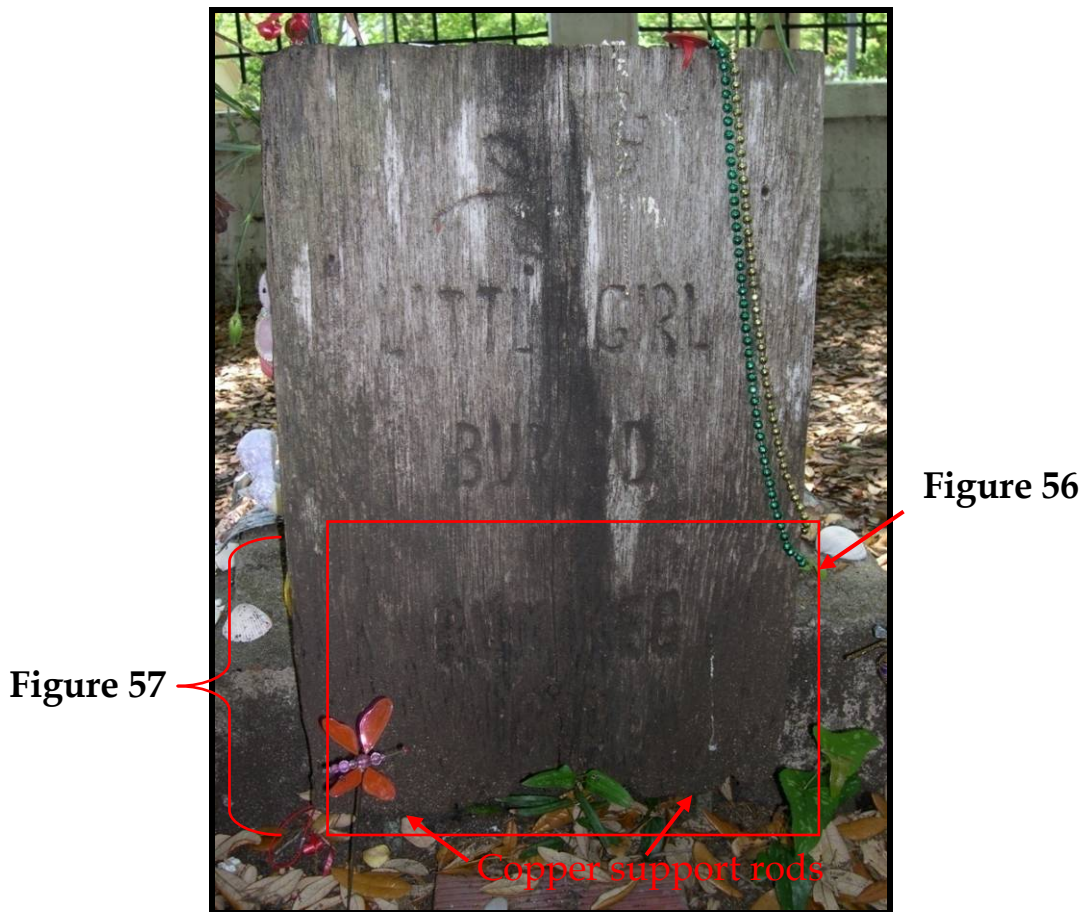
Figure 55. The grave marker of the little girl buried in a rum keg. Note the copper support rods.

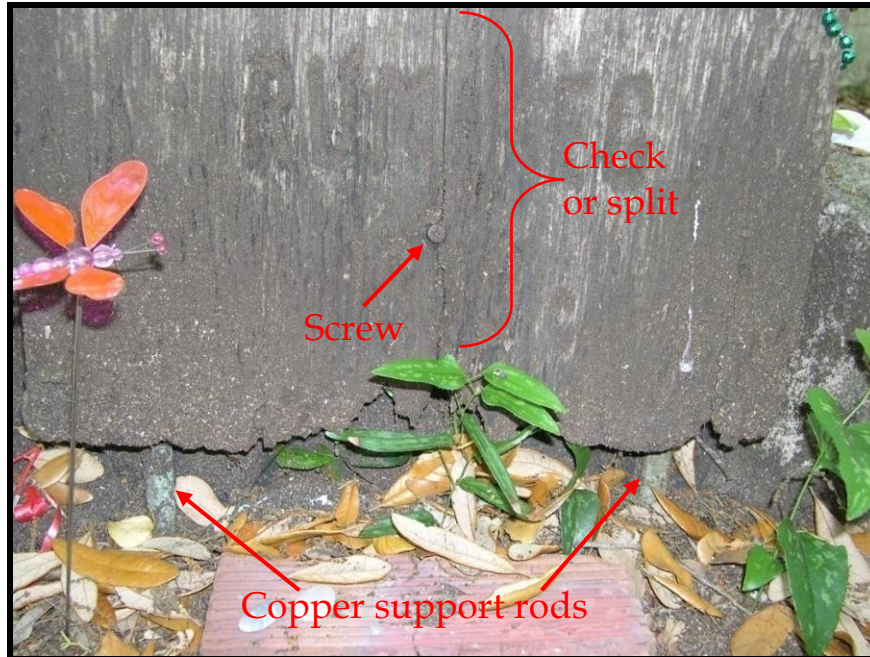
Figure 56. A close-up of the base of the marker showing two copper supports. The wooden marker is no longer in contact with the ground. Note the screw on the face used to hold the historic marker in place and the check likely caused by its installation.

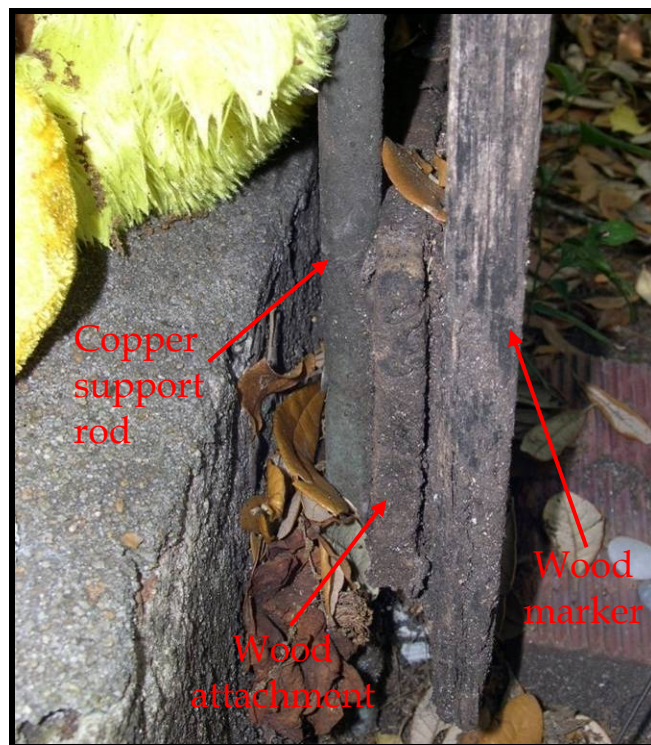
Figure 57. A close-up of the side view of the repair showing the wood the marker has been sandwiched to and the copper pipe, along with organic debris.

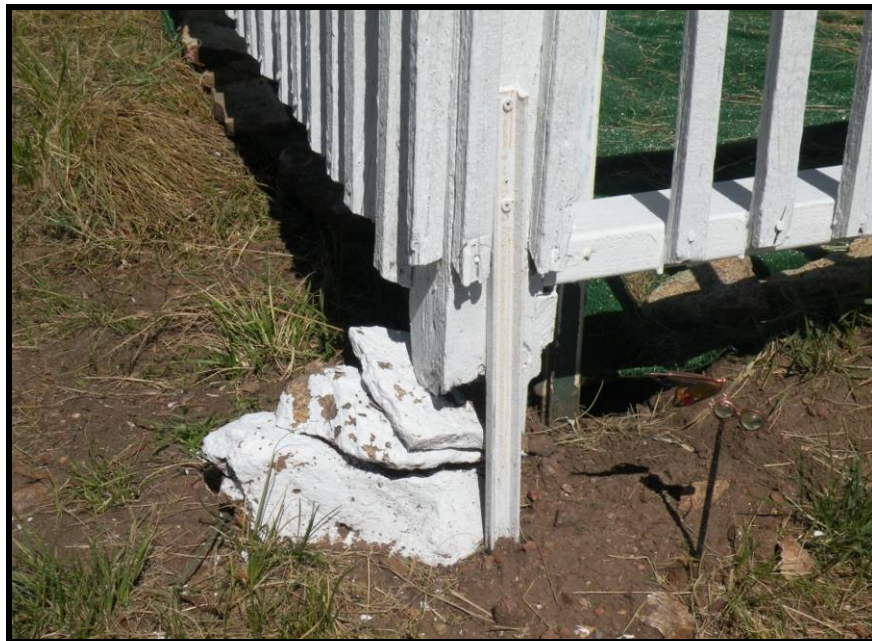
Figure 58. The deteriorated base of a grave enclosure corner post has been replaced by a channeled metal rod and natural stones, painted white.

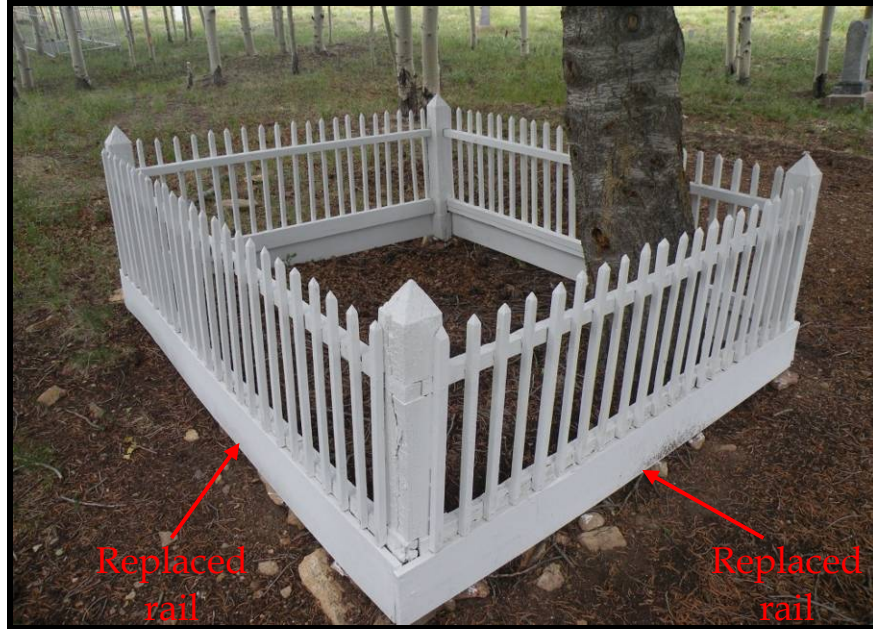
Figure 59. This grave enclosure has had its base rail replaced and the degraded corner posts now sit on stone piers.

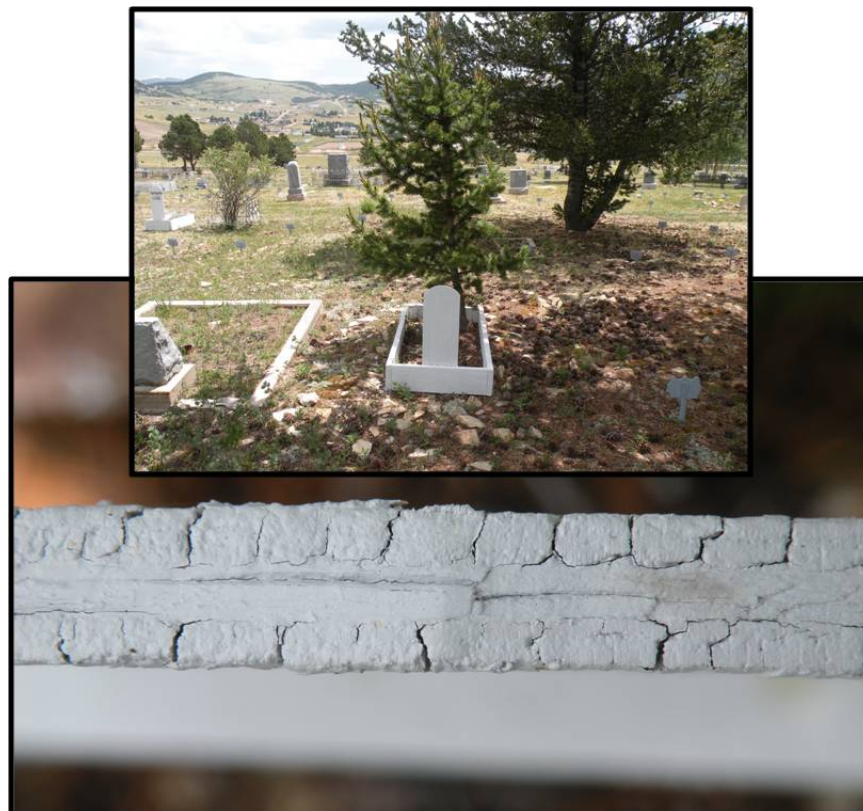
Figure 60. The top photograph shows a grave marker and grave curb. The original wooden marker was replaced with one of plywood, a material not suited for exterior conditions. The bottom photograph is a close-up of the top of the marker; through the paint the effects of weathering and the beginning of de-lamination are evident.
