# 48 PRESERVATION BRIEFS

## Preserving Grave Markers in Historic Cemeteries

National Park Service  
U.S. Department of the Interior

Technical Preservation Services

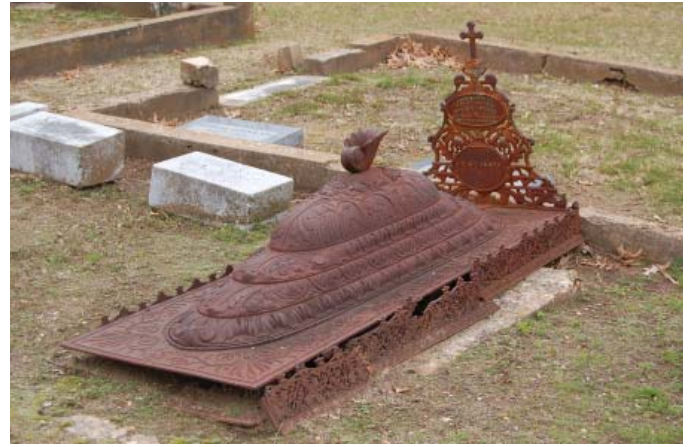
Figure 6. Decorative cast-iron grave markers like this late-19th century one in Oakland Cemetery in Shreveport, LA, are produced by heating the iron alloy and casting the liquid metal into a mold. Photo: Jason Church.

Metals are solid materials that are typically hard, malleable, fusible, ductile, and often shiny when new (Fig. 6). A metal alloy is a mixture or solid solution of two or more metals. Metals are easily worked and can be melted or fused, hammered into thin sheets, or drawn into wires. Different metals have varying physical

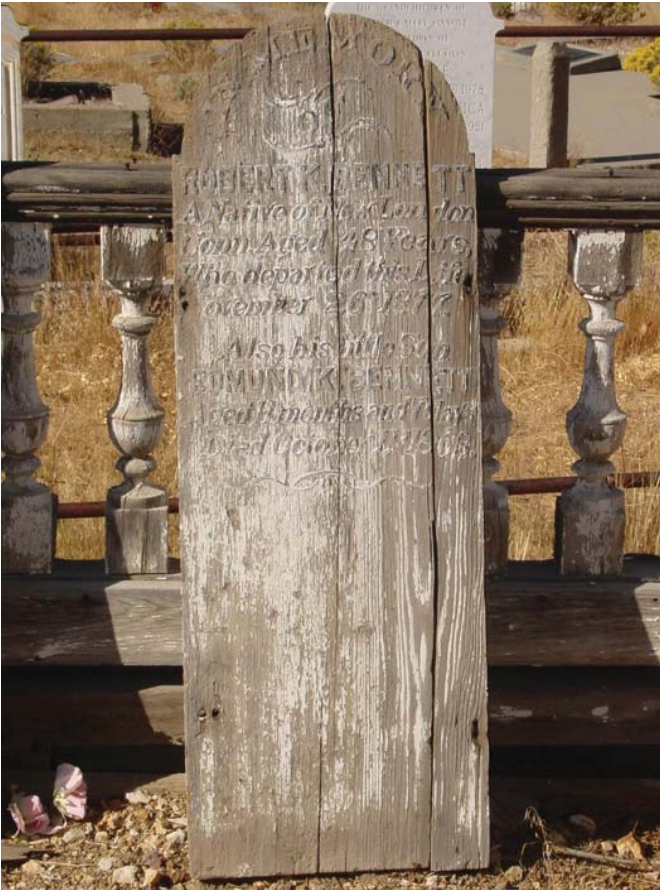
Figure 7. As shown by this 1877 marker in Silver Terrace Cemetery, Virginia City, NV, exposure to sunlight can damage wood grave markers, making the wood more susceptible to water damage and cracking. Photo: Jason Church.

appearance and influence wood properties. Wood-cell walls and cavities contain moisture. Oven drying reduces the moisture content of wood. After the drying process, the wood continues to expand and contract with changes in moisture content. The loss of water from cell walls causes wood to shrink, sometimes distorting its original shape (Fig. 7).

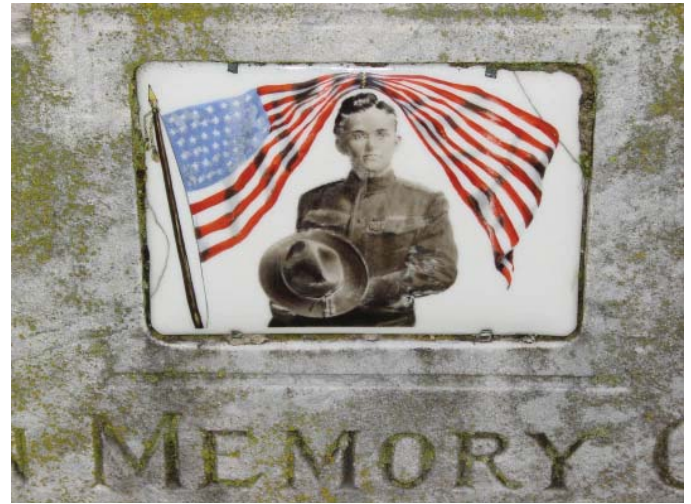
Figure 8. A fired ceramic, this cameo is set in a marble grave marker, located in Elmwood Cemetery, Memphis, TN. Different materials may require different conservation approaches. Photo: Mary Striegel.

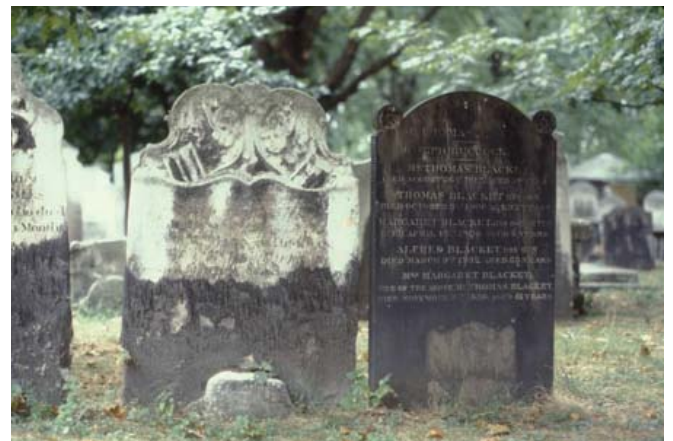
Figure 9. The limestone and sandstone grave markers in this historic cemetery have different weathering processes. On the left, the limestone shows surface loss in areas exposed to rainwater and gypsum crust formation below. The sandstone marker on the right displays uniform soiling, but surface hardening may be occurring. Photo: Fran Gale.

All grave marker materials deteriorate when they are exposed to weathering such as sunlight, wind, rain, high and low temperatures, and atmospheric pollutants (Fig. 9). If a marker is composed of several materials, each may have a different weathering rate. Some weathering processes occur very quickly, and others gradually affect the condition of materials. Weathering results in deterioration in a variety of ways. For example, when exposed to rainwater some stones lose surface material while others form harder outer crusts that may detach from the surface.

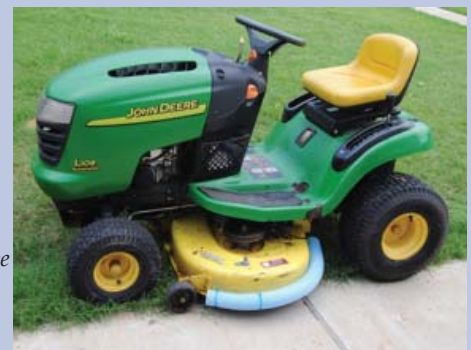
*Figure B. A pool ‘noodle’ can be fitted to the deck of a lawnmower to prevent damage to grave markers. Photo: Debbie Dietrich Smith.*

Regarding lawn care, historic cemeteries were not designed for today’s large riding lawnmowers, yet this is the mower of choice for many cemeteries, as mowing is one of the most time-consuming and costly maintenance tasks generally undertaken. Mowing between tight spots with a large riding mower deck is destined to cause damage. Best practices include using a smaller, push mower between particularly sensitive features, and outfitting riding mower decks with protective bumpers. Low-cost options include using fire hose padding or a foam swimming ‘noodle’ (Fig. B). Additional damage is caused by riding over low stones or coping, especially when the blade height is set low. If rolling over these features is unavoidable, many riding mowers have a hand-control adjustment to temporarily raise and lower the blade height.

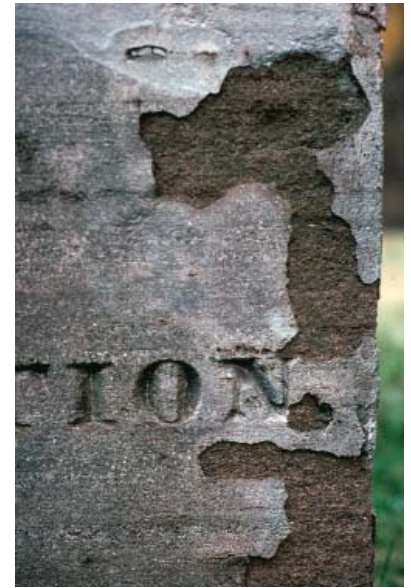
Figure 13. The impervious coating used to "protect" this sandstone grave marker trapped moisture within the stone, eventually resulting in deterioration and surface loss. Photo: Fran Gale.

Repointing masonry grave markers using Portland cement mortars that are harder than historic mortars often results in accelerated deterioration of the masonry material. Mortar should be softer than the adjacent masonry, enabling trapped moisture to migrate out, and serve as the sacrificial material when cracking occurs to relieve excessive stress. Problems also result when using impervious "protective" coatings that can trap moisture within the masonry, resulting in damage during wet/dry and freeze/thaw cycles (Fig. 13).

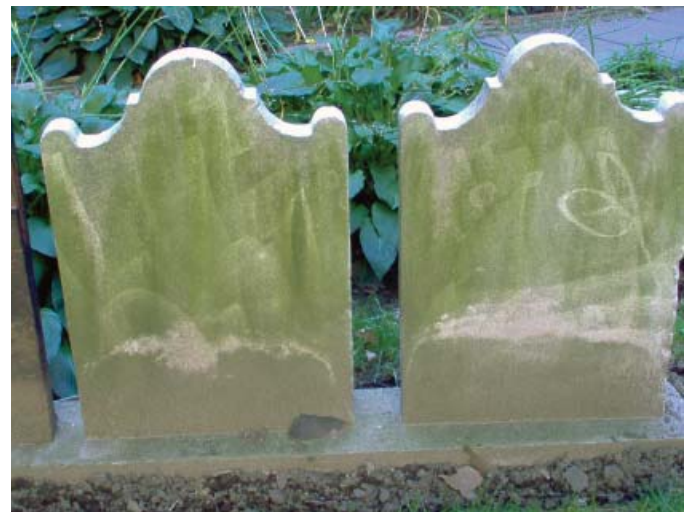
Figure 14. High-pressure water washing can damage grave markers. The photograph shows "wand marks" on the headstones produced by inappropriate pressure washing. Photo: Jason Church.

Harsh cleaning products and techniques can have a detrimental effect on grave markers. Acidic cleaners such as muriatic acid can dissolve minerals in many masonry materials and can attack metals. Alkaline cleaners, such as bleach, are notorious for leaving residual salts that are deposited on the surface (a process called efflorescence). Both acidic and alkaline cleaning can result in staining, especially if rinsing is inadequate. Using high-pressure water, above 500 to 1,000 psi, can needlessly damage masonry materials as well, increasing their vulnerability to weathering (Fig. 14). If the marker is fragile, even low pressure water can be damaging. Techniques to avoid include aggregate blasting with sand or other harsh media and the use of power tools with abrasive wire or Nylox™ brushes.

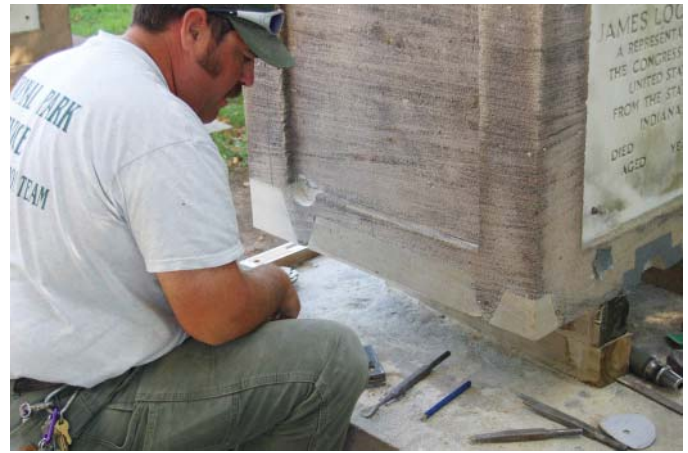
Figure 16. A professional mason works to insert a new piece of stone. Often referred to as a “dutchman”, this repair technique requires replacing the deteriorated stone section with a new finished piece of the same size and material. Photo: Jason Church.

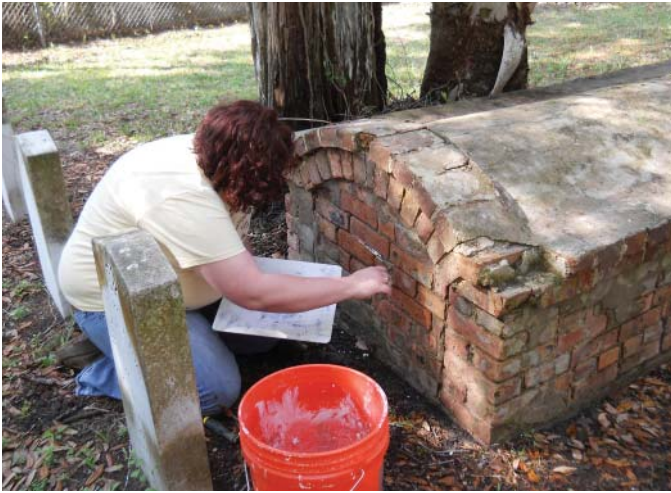
Figure 19. Masonry markers like this box tomb may require the repointing of mortar joints. It is important to use a mortar that is softer than the historic brick. In this case a conservator uses a lime putty-based mortar to repoint. Photo: Jason Church.

Missing and deteriorated mortar in old cemetery grave markers is a common condition, and the mortar should be replaced to prevent water intrusion and potential damage (Fig. 19). Several questions should be considered when selecting materials for repointing.

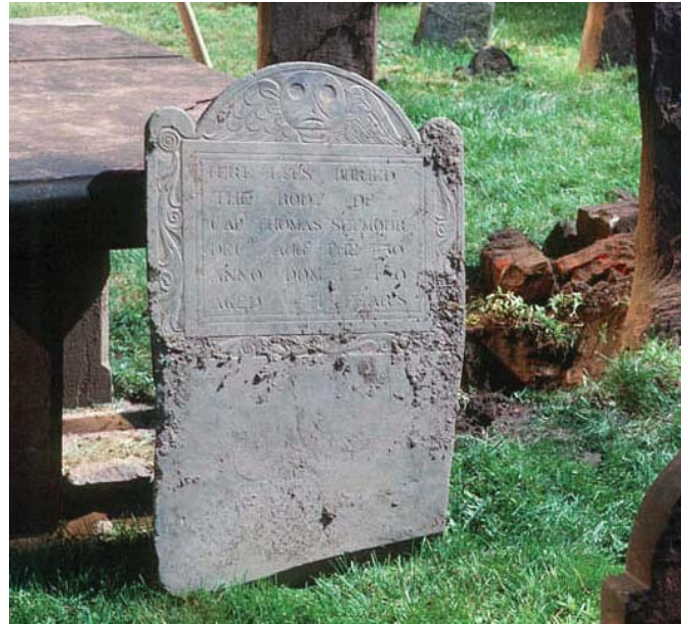
Figure 20a. This slate grave marker in the Ancient Burying Ground in Hartford, CT, is a ground-support stone. Resetting requires digging a hole that will hold the base of the stone and then compacting the soil at the bottom of the hole by hand. Photo: Fran Gale.

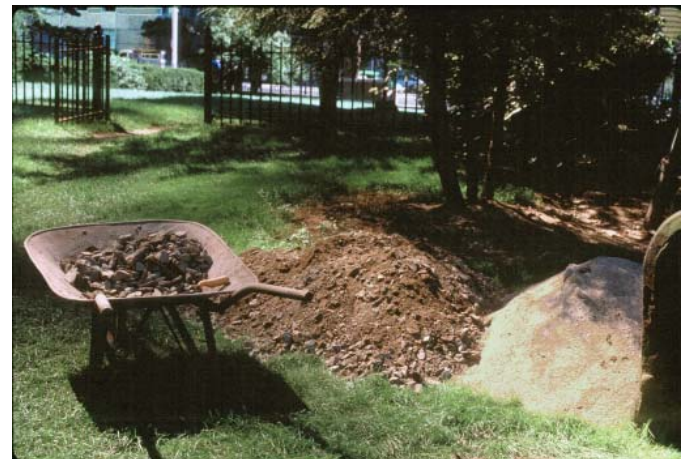
Figure 20b. To facilitate drainage, crushed stone, gravel, and sharp sand line the hole and are hand-tamped around the stone after placement. Photo: Fran Gale.

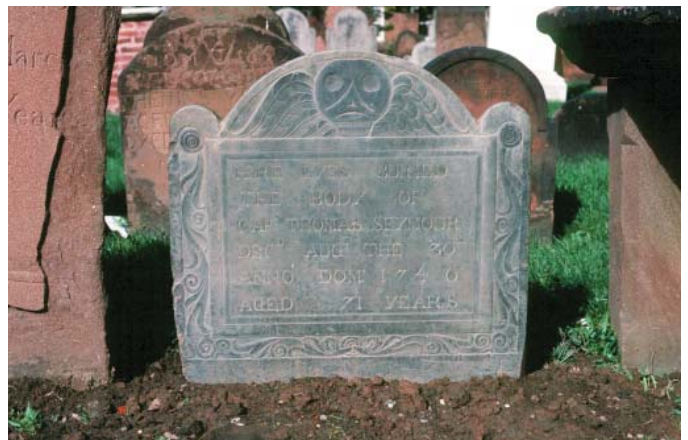
Figure 20c. The reset ground-supported grave marker should be level and plumb. Photo: Fran Gale.
